# **Helensburgh Coastal Flood Protection Study - Information Review Report**

**Final Report**

September 2018

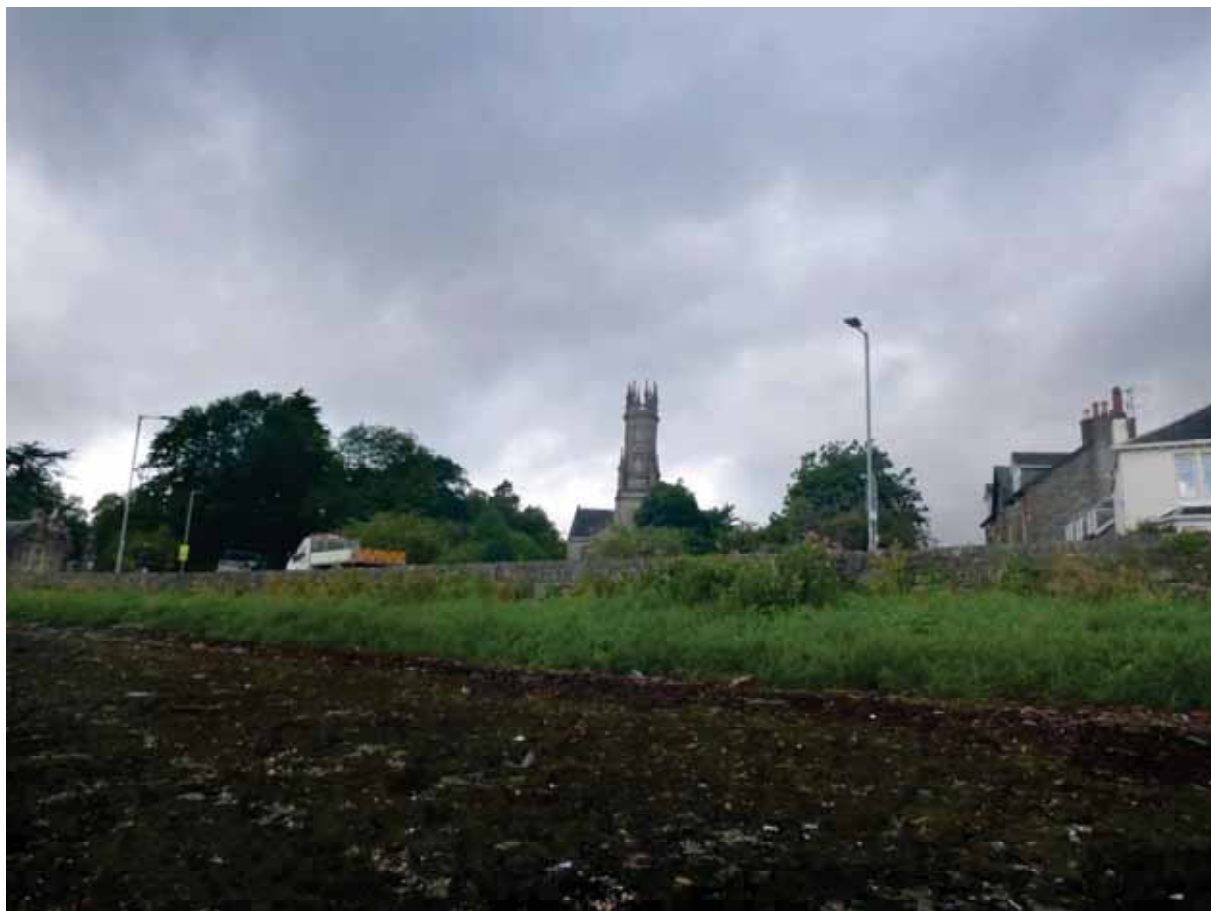
**Figure 4-4: Photograph of defence within section A**

Section A consist of a grass bank backed by a masonry wall. The A814 sits directly behind the masonry wall.

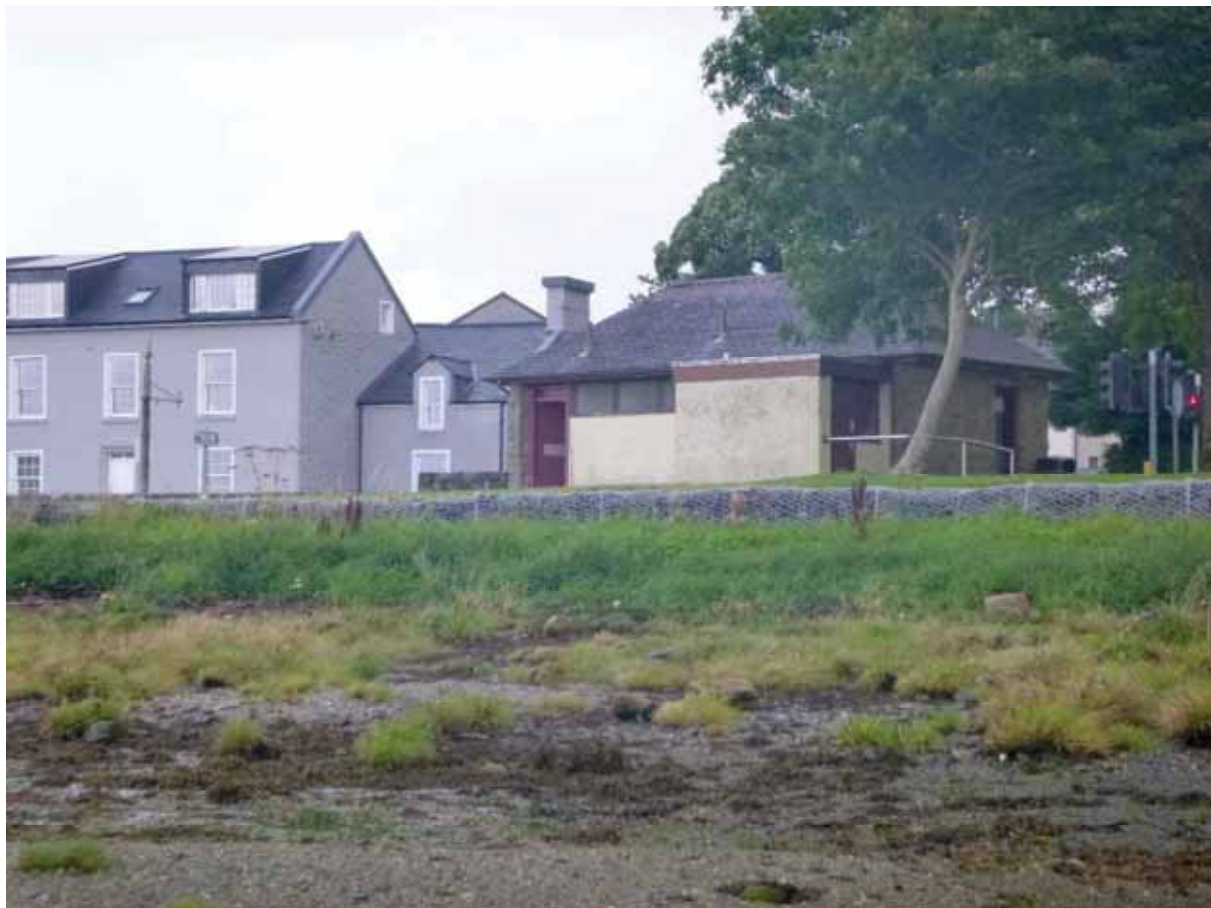
**Figure 4-6: Photograph of defence within section B**

Section B consist of a grass bank backed by gabion baskets.

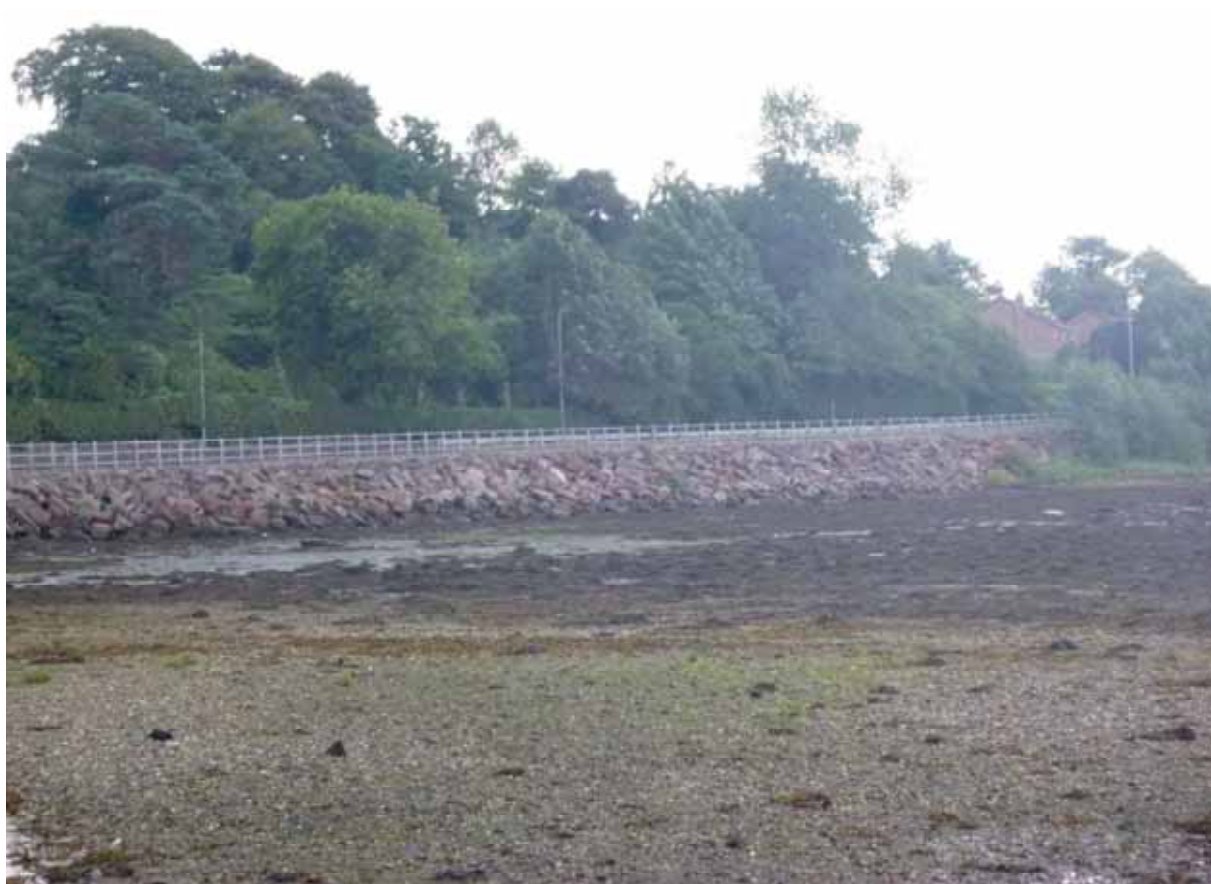
**Figure 4-8: Photograph of defence within section C**

Section C consist of a rock armour revetment and low masonry wall. The A814 is located directly behind the defence.

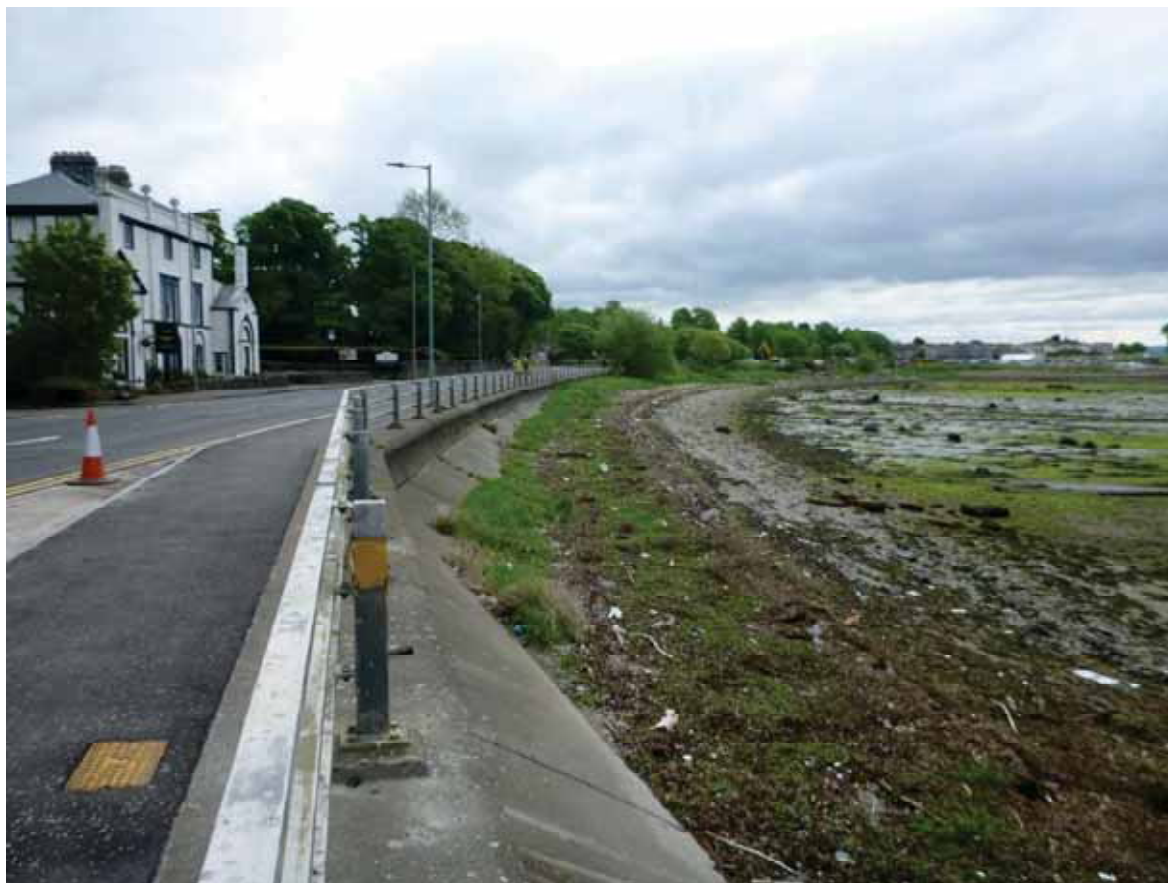
**Figure 4-10: Photograph of defence within section D**

Section D consists of a small concrete revetment topped by a concrete wave return wall, which is relatively consistent along its length. The vegetation at the toe indicates that the western end is more exposed to direct wave attack.

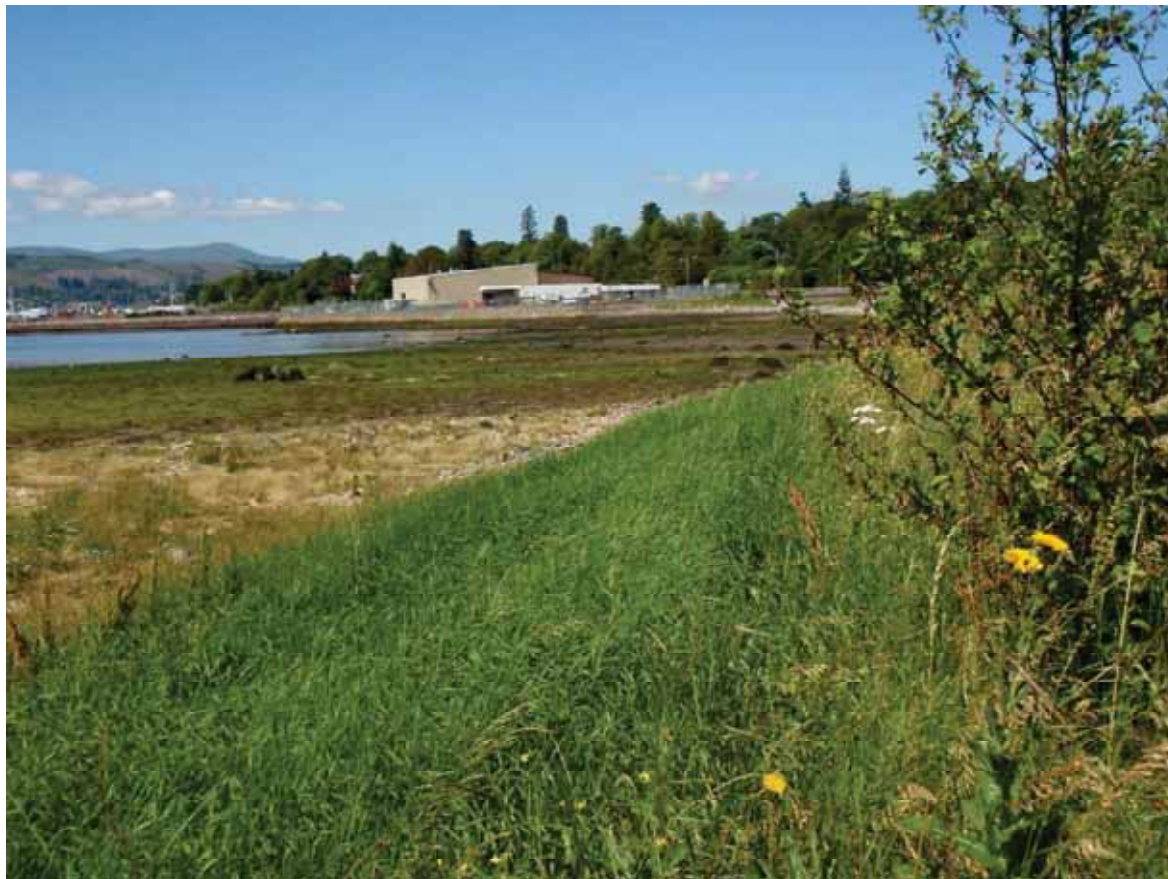
**Figure 4-12: Photograph of defence within section E**

Section E lies to either side of the Glenoran Burn, that discharges beside the sailing club. No formalised defence structures exist, with the shoreline consisting of a shingle and grass embankment.

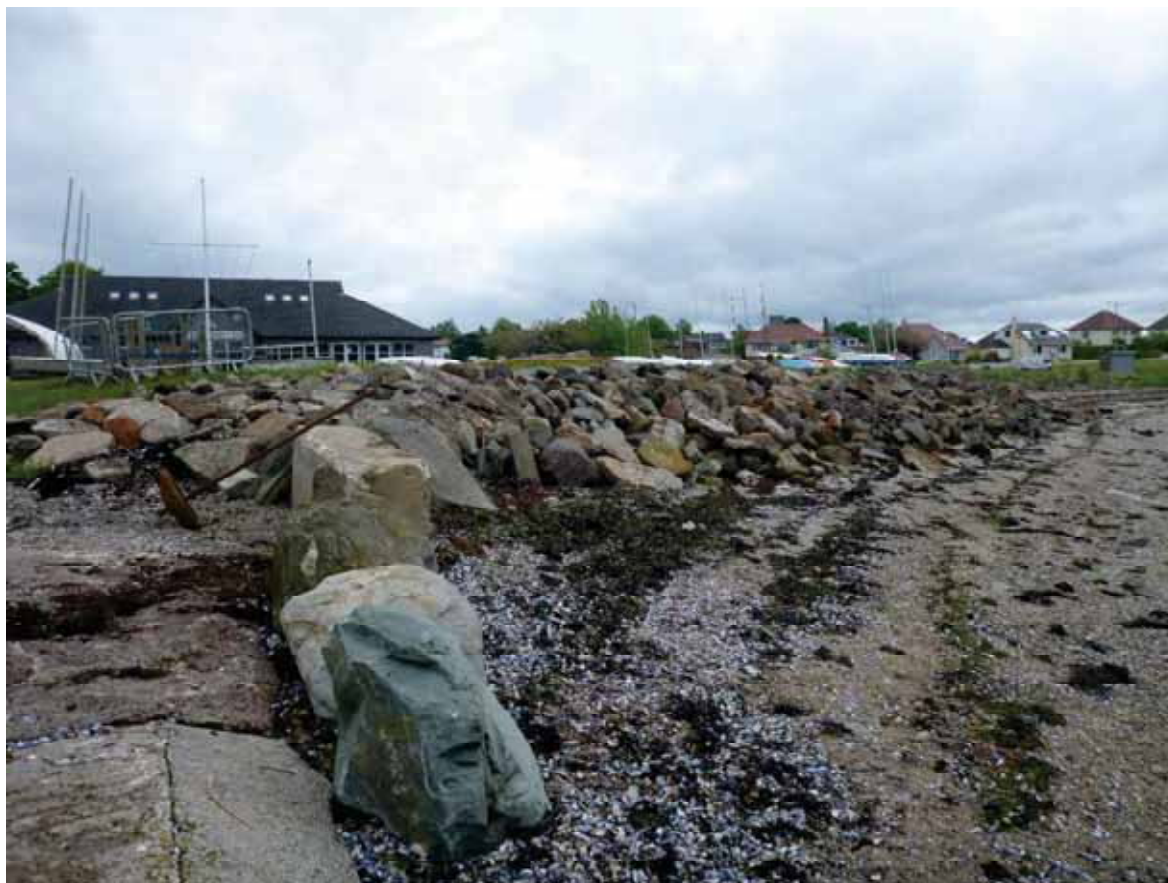
**Figure 4-14: Photograph of defence within section F**

Section F is the main section of defence protecting the sailing club. It primarily consists of a rock armour embankment on top of a shingle beach. Visual inspection indicates that the sizing is irregular, suggesting that this may not be a formal structure.

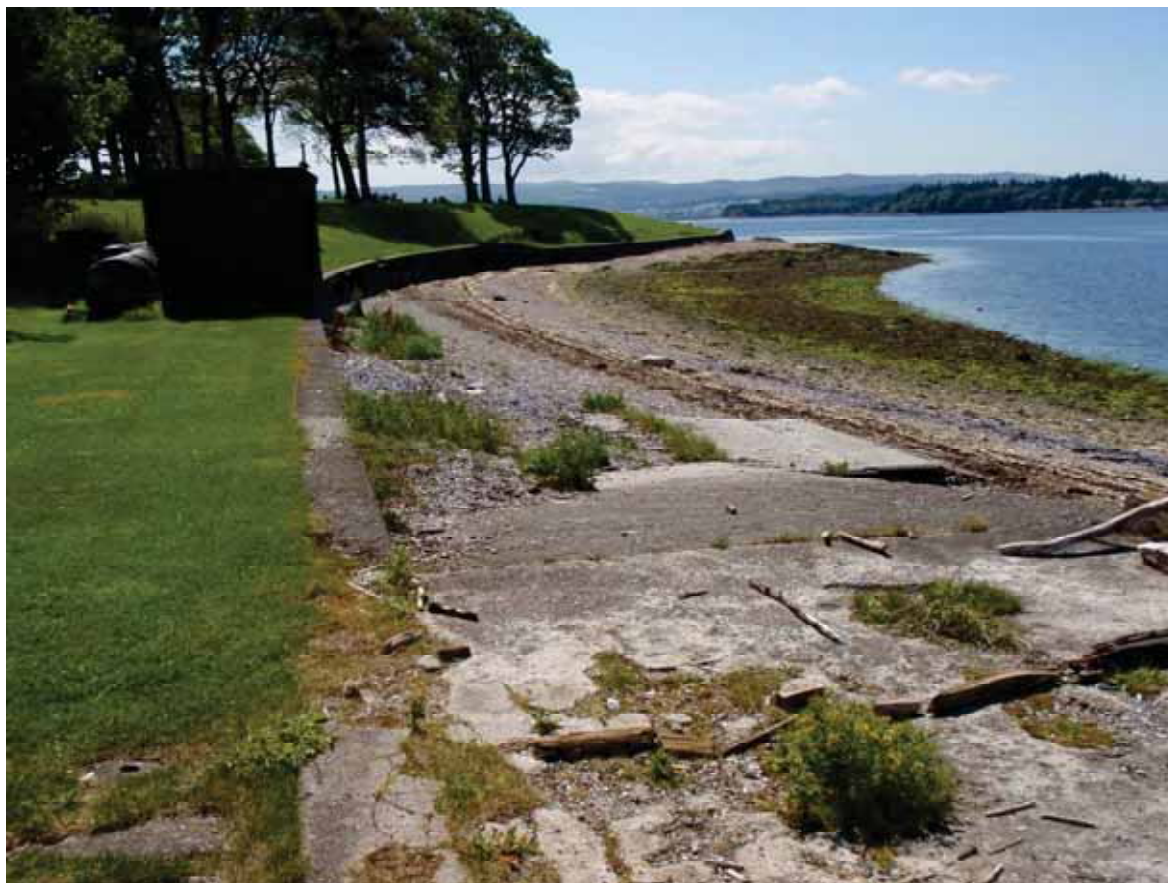
**Figure 4-16: Photograph of defence within section G**

Section G protrudes into the firth and consists of a shingle beach topped with a small concrete wall. The land behind rises sharply with no risk of flooding to any properties or infrastructure from overtopping.

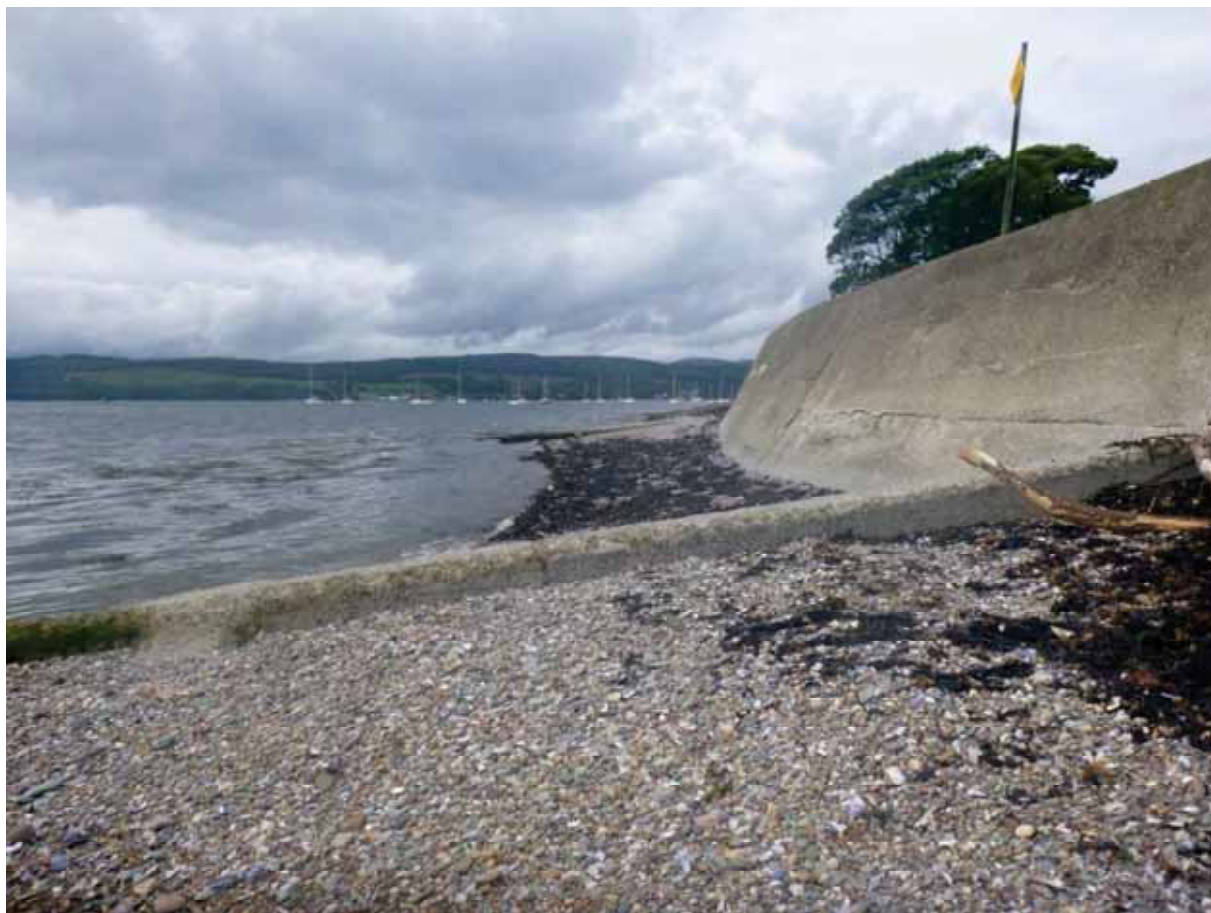
**Figure 4-18: Photograph of defence within section H**

Section H forms the defence in front of the park area. The land behind rises sharply with no risk of flooding to any properties or infrastructure from overtopping.

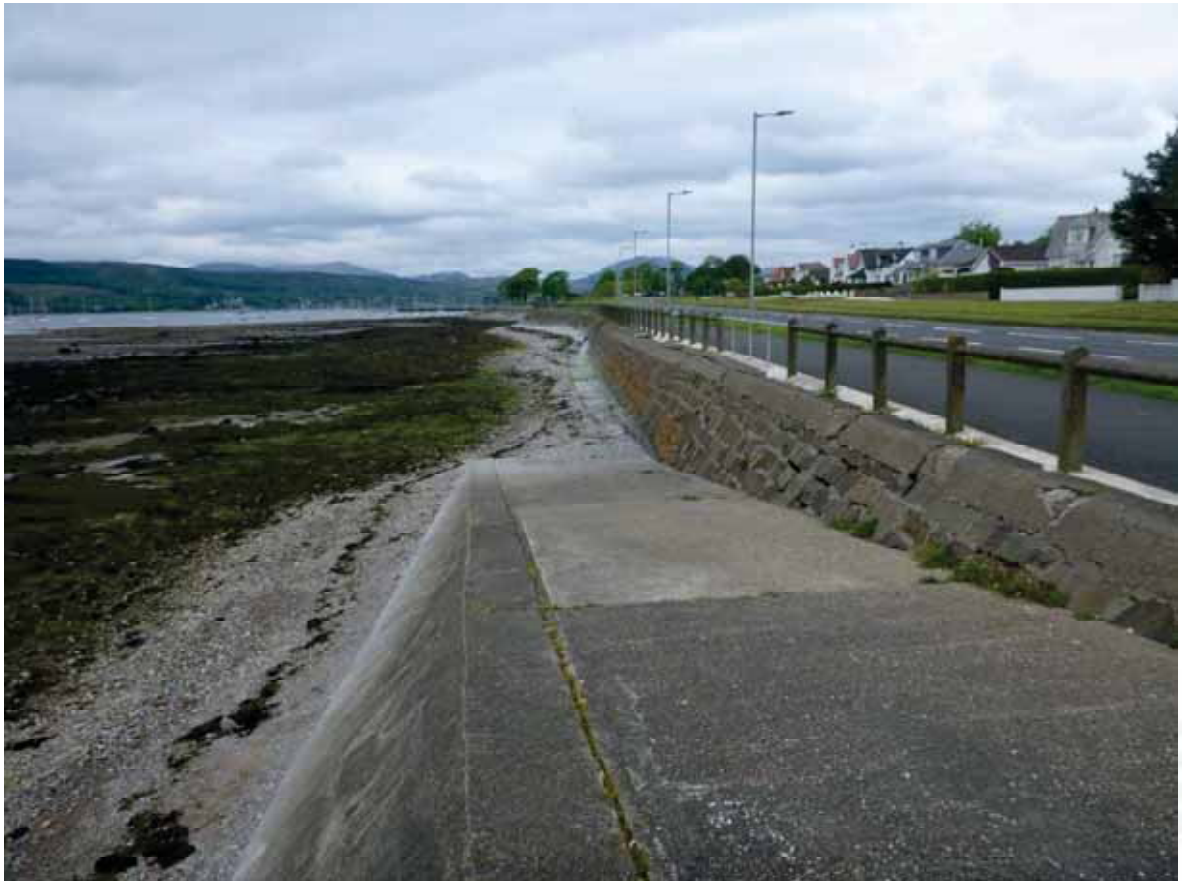
**Figure 4-20: Photograph of defence within section I**

Section I forms the first section of defences at the western end of Lower Rhu Road (A814). The defence consists of a sloping masonry revetment at the top of the shingle beach.

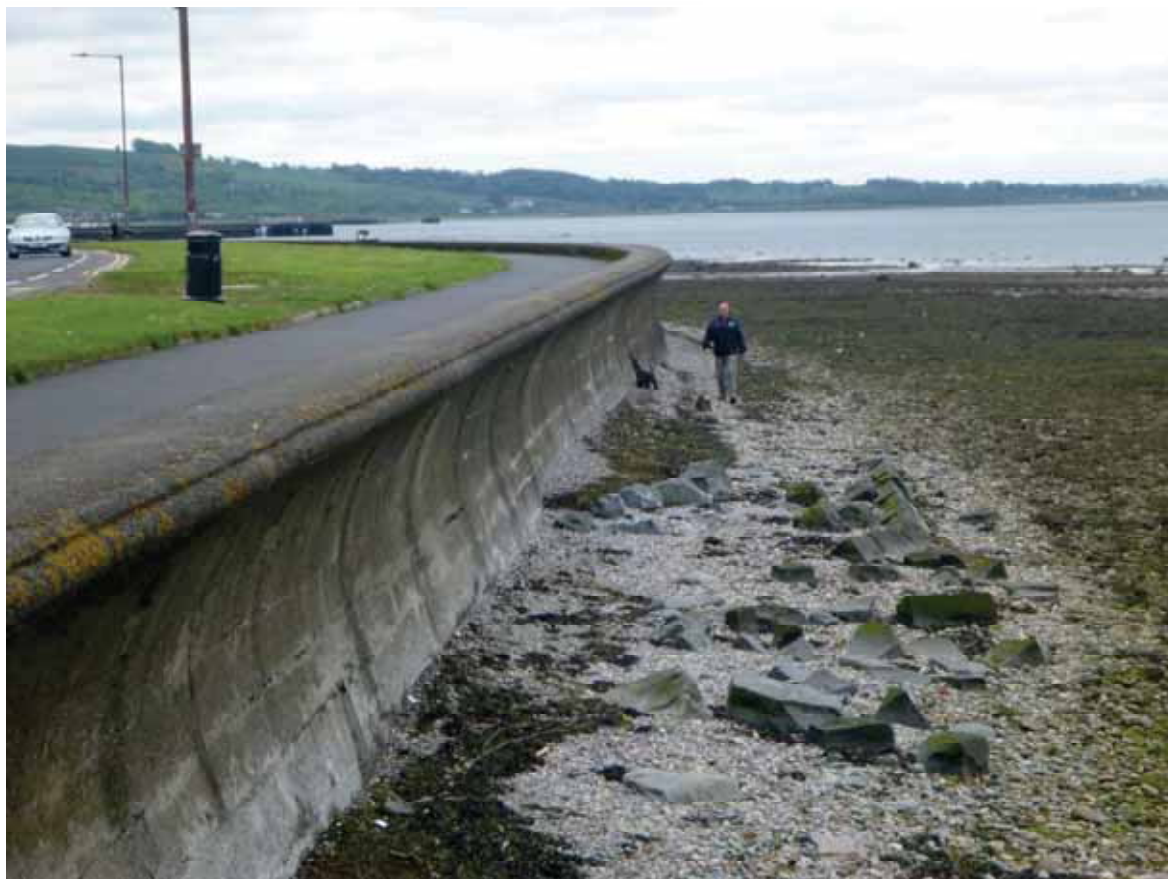
**Figure 4-22: Photograph of defence within section J**

Section J is considered as the primary coastal defence along Lower Rhu Road (A814). It consists of a large concrete wave return wall at the top of the shingle beach.

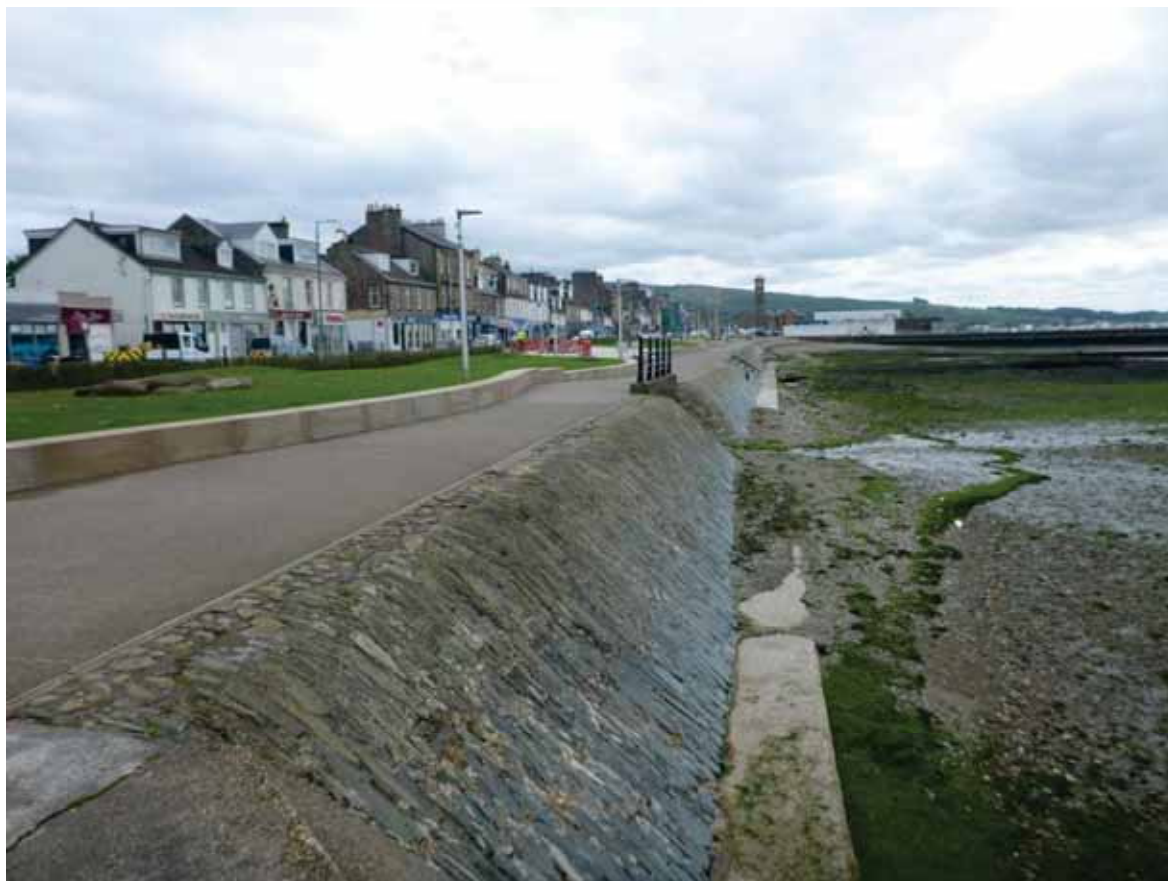
**Figure 4-24: Photograph of defence within section K**

Section K is considered as the primary coastal defence along the main pedestrian frontage. It consists of a masonry revetment at the top of the shingle beach. Landward of the revetment, recent development has resulted in a small concrete wall that will potentially reduce the overtopping reaching the road and properties.

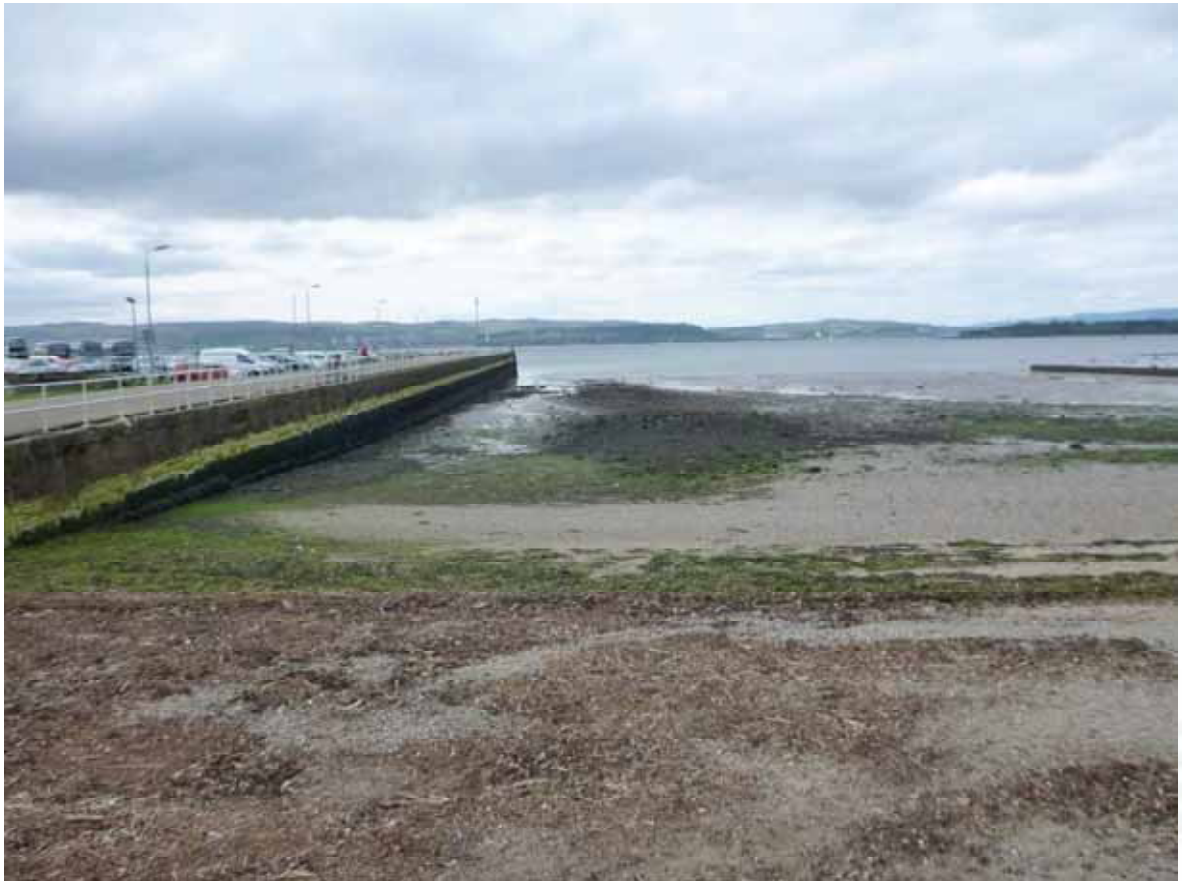
**Figure 4-26: Photograph of defence within section L**

Section L consists of a masonry wall on the western side of the main pier. It extends directly into the firth from the beach and is consistent in construction and orientation along the entire length.

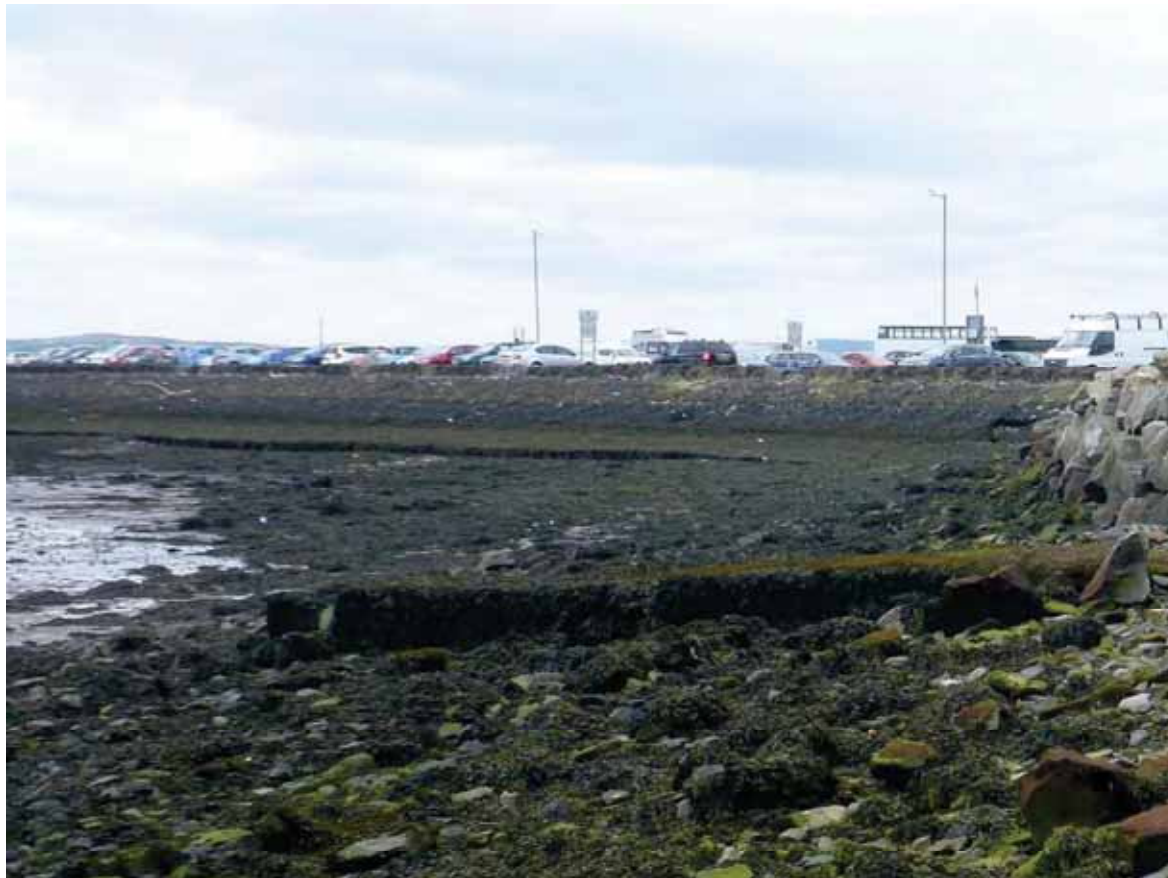
**Figure 4-30: Photograph of defence within section N**

Section N forms the eastern side of the main pier. It consists of a masonry revetment topped by gabions filled with small stones.

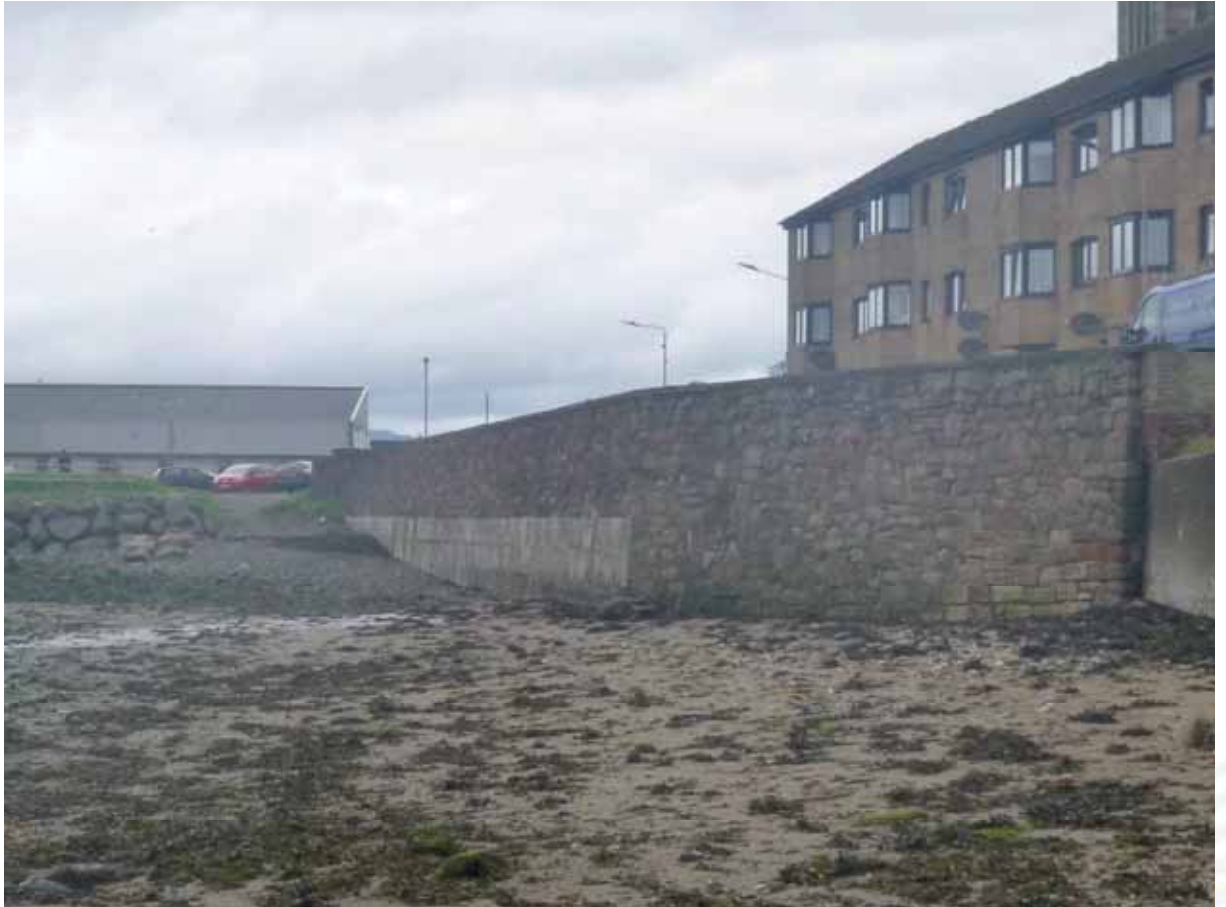
**Figure 4-34: Photograph of defence within section P**

Section P consists of a masonry boundary wall to properties that back onto the beach.  
Argyll & Bute Council ref: A814 090 W22

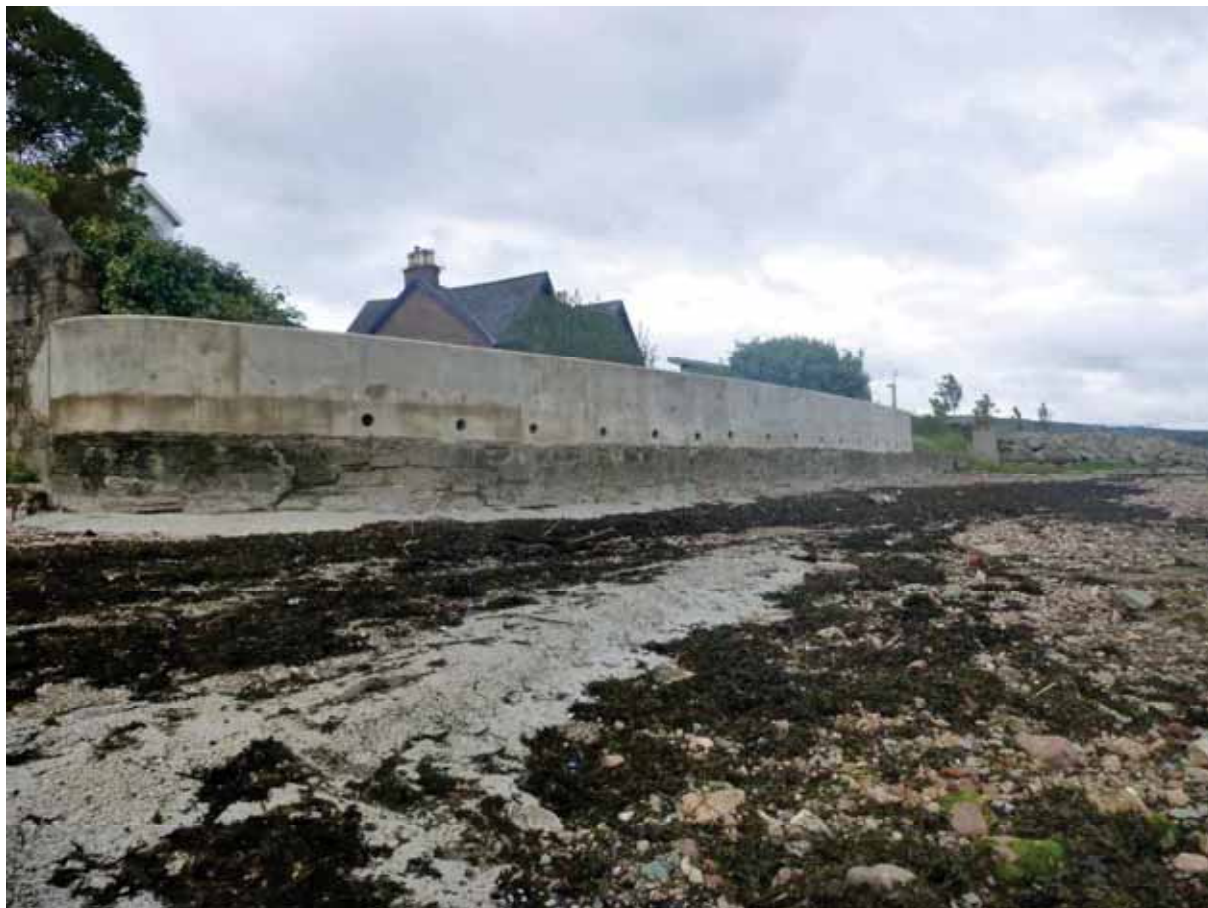
**Figure 4-36: Photograph of defence within section Q**

Section Q consists of a concrete boundary wall to properties that back onto the beach.  
Argyll & Bute Council ref: A814 090 W12

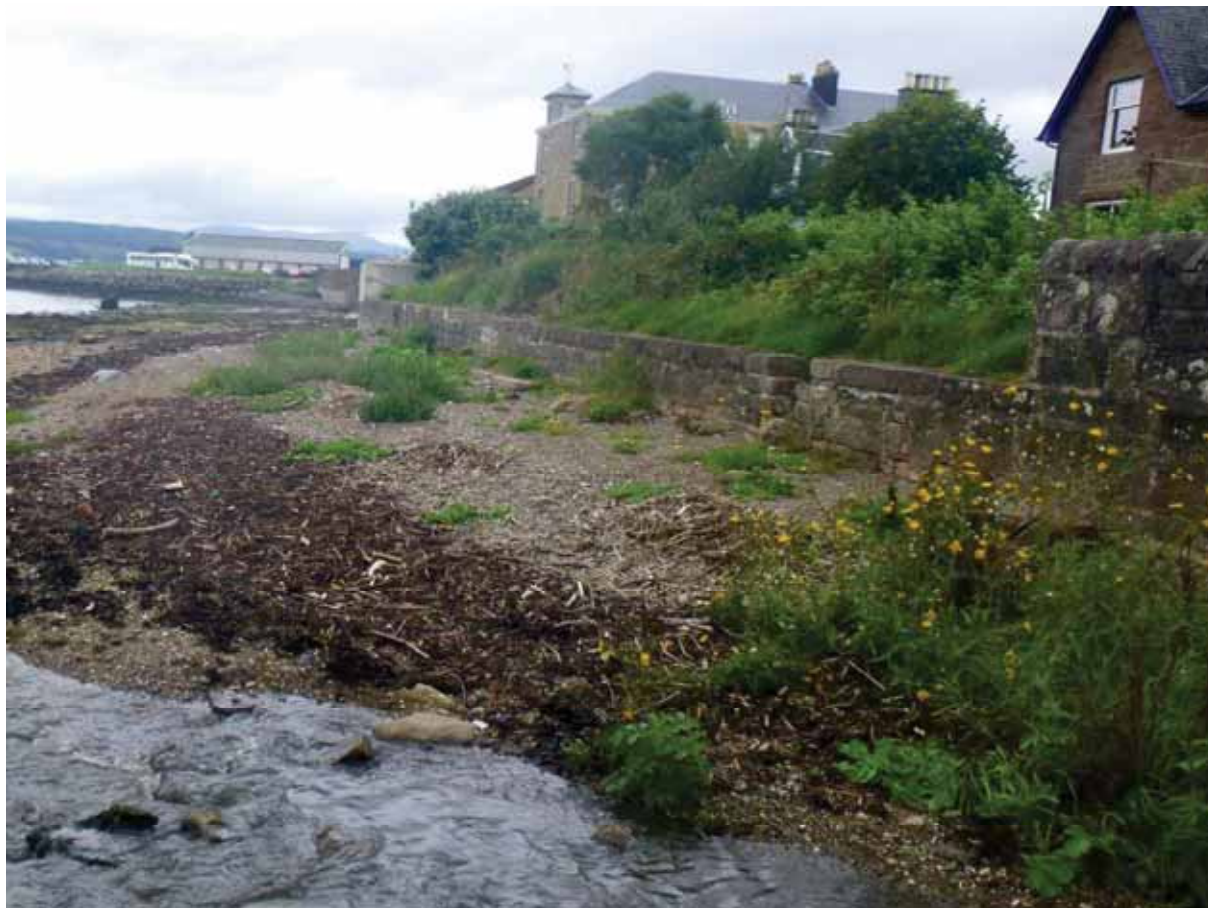
**Figure 4-38: Photograph of defence within section R**

Section R consists of a masonry boundary wall to properties that back onto the beach.  
Argyll & Bute Council ref: A814 090 W06

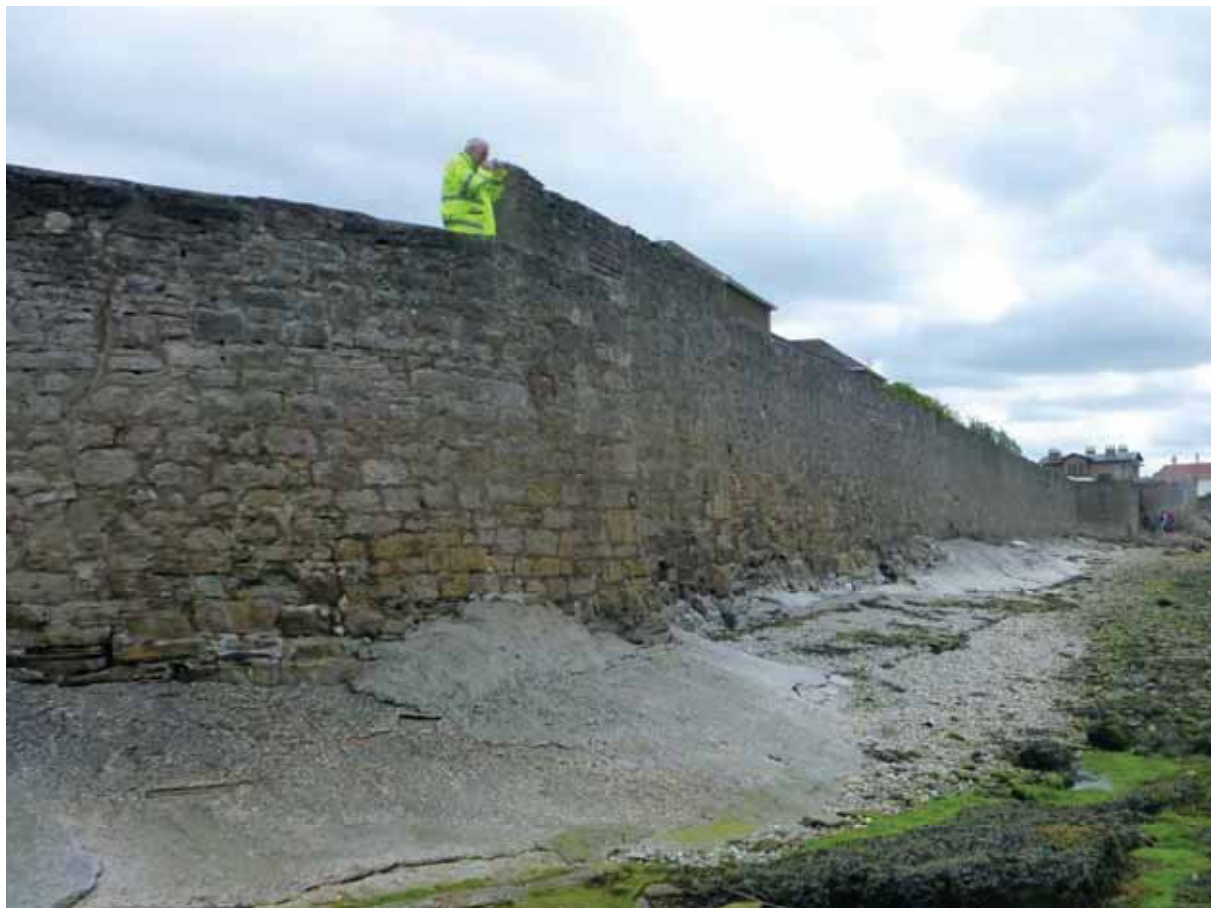
**Figure 4-48: Photograph of defence within section W**

Section W consists of a private property boundary that borders the beach.

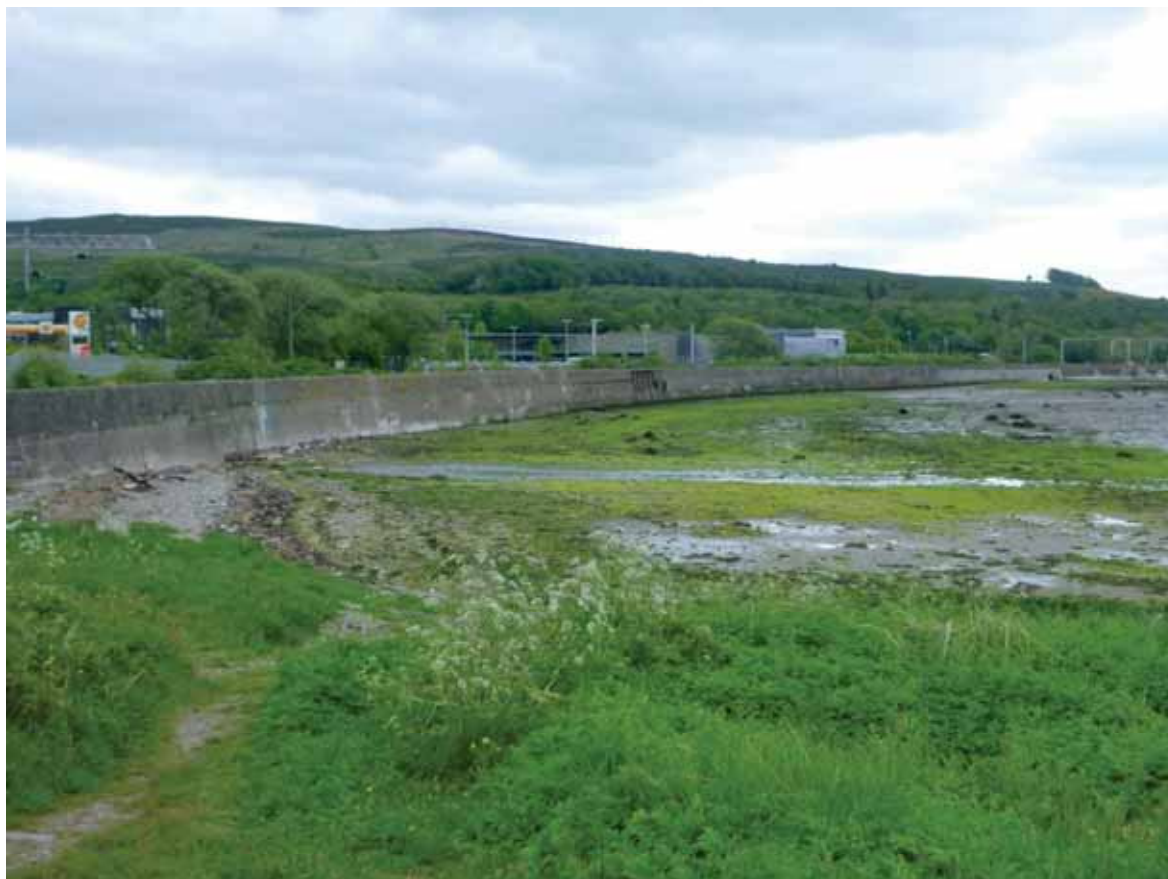
**Figure 4-64: Photograph of defence within section AE**

Section AE is the main coastal defence protecting the railway from wave overtopping. It consists of a uniform vertical concrete wall along the entire length. The toe of the structure is well above low water and the water marks observed suggest that little submersion occurs even at high tide.

**Recommendation:** It is recommended that a visual structural survey to classify the defences, assess their condition, record defects, assess residual life and where possible assess toe depth is undertaken.
