# **Helensburgh Coastal Flood Protection Study - Information Review Report**

**Final Report**

September 2018

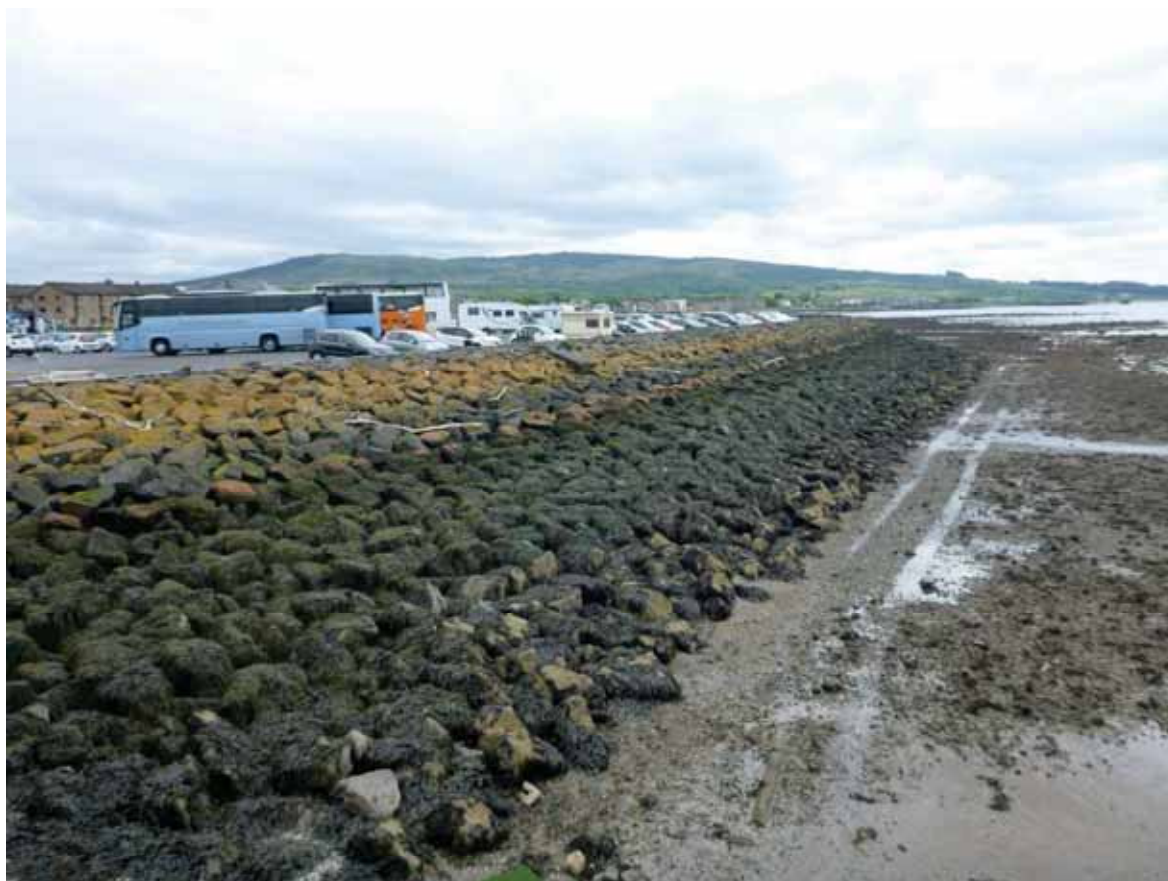
**Figure 4-28: Photograph of defence within section M**

Section M is rock armour revetment placed along the southern side of the main pier. Tide marks show that at least half of the structure is submerged during high waters, meaning that overtopping is likely significant during extreme events.

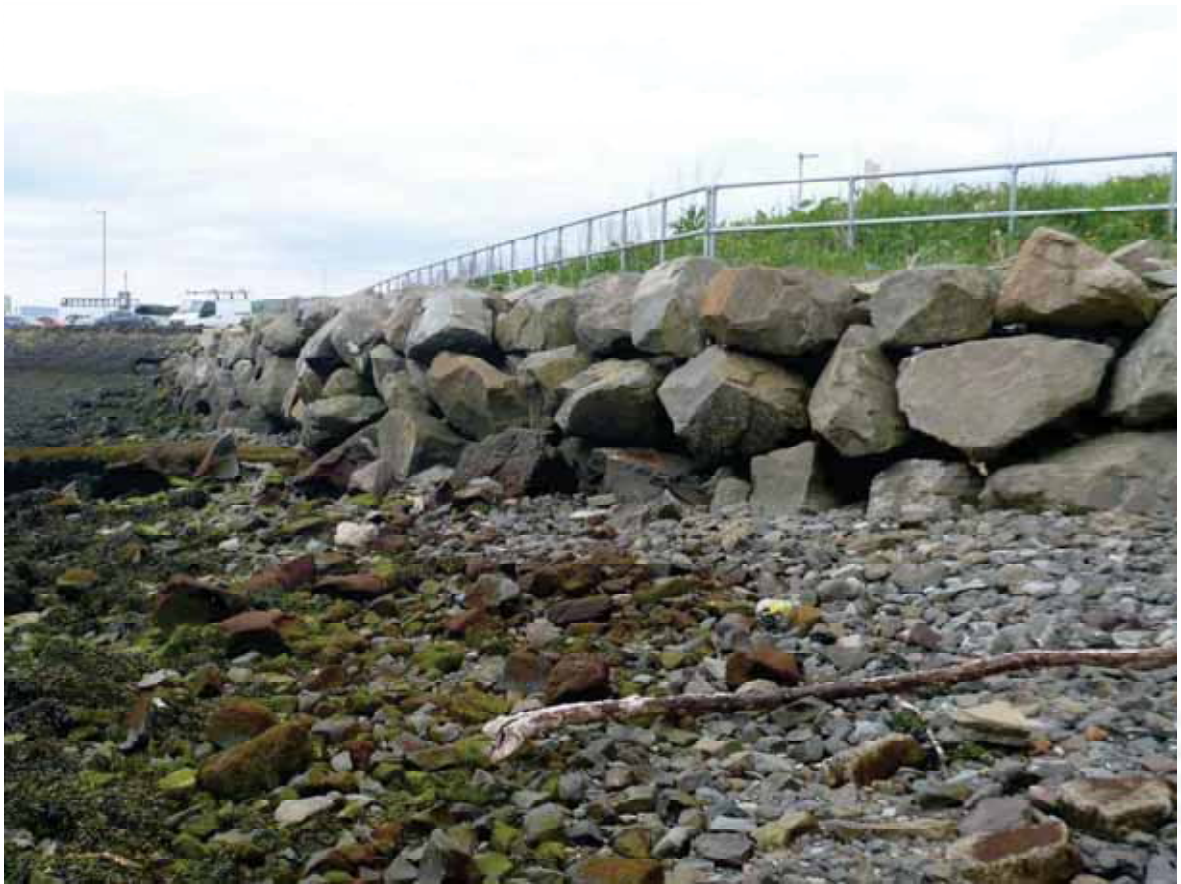
**Figure 4-32: Photograph of defence within section O**

Section O forms the final section of coastal defence on the eastern side of the pier. It consists of a rock armour revetment placed in a near vertical profile.

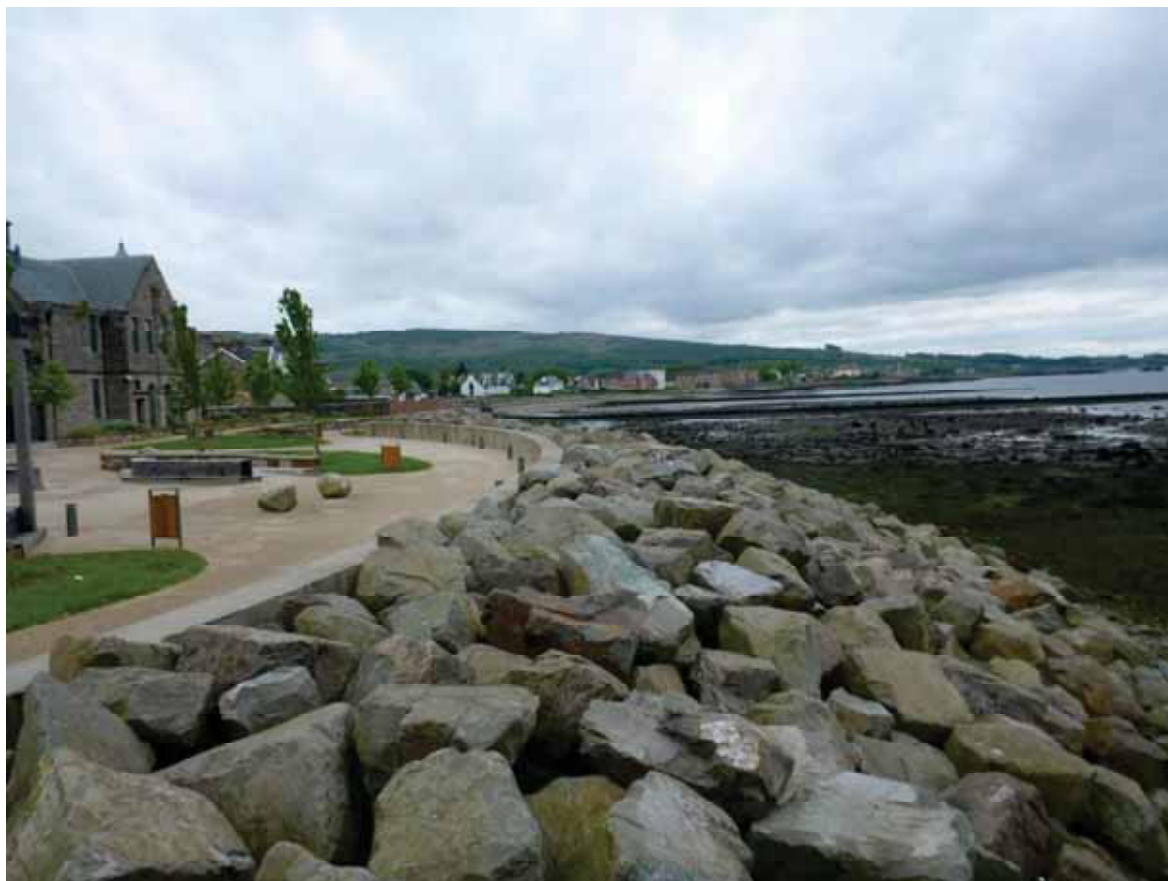
**Figure 4-40: Photograph of defence within section S**

Section S consists of the rock armour revetment that bounds the Civic Centre. Details of the outline design are provided in the Akins 2011 design report.

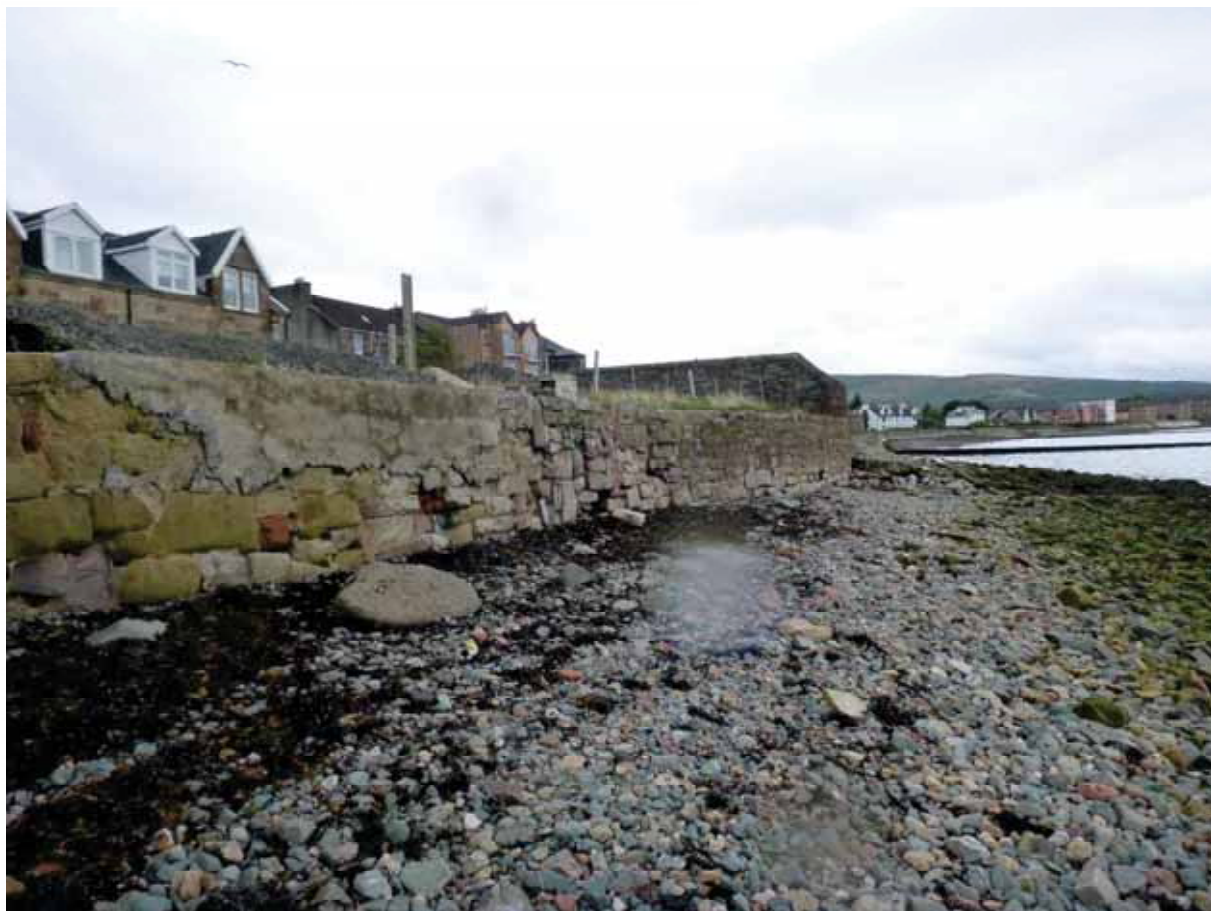
**Figure 4-42: Photograph of defences within section T**

Section T lies to the east of the Civic Centre and consists of private property boundaries. The masonry walls vary in height along the section.

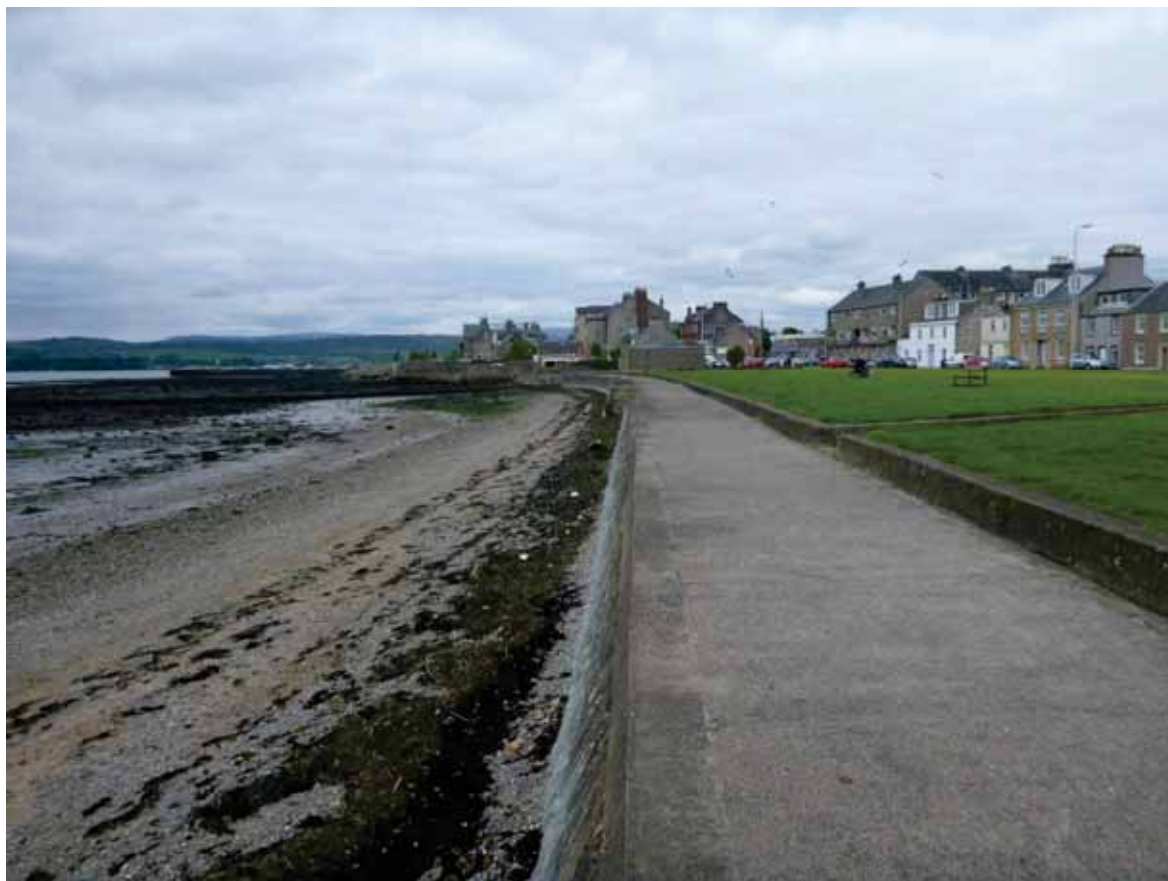
**Figure 4-44: Photograph of defence within section U**

Section U consists of a masonry revetment at the top of the shingle beach. Landward of the revetment, a small concrete wall exists that will potentially reduce the overtopping reaching the road and properties during minor events. Flood history shows that this location is prone to high levels of overtopping.

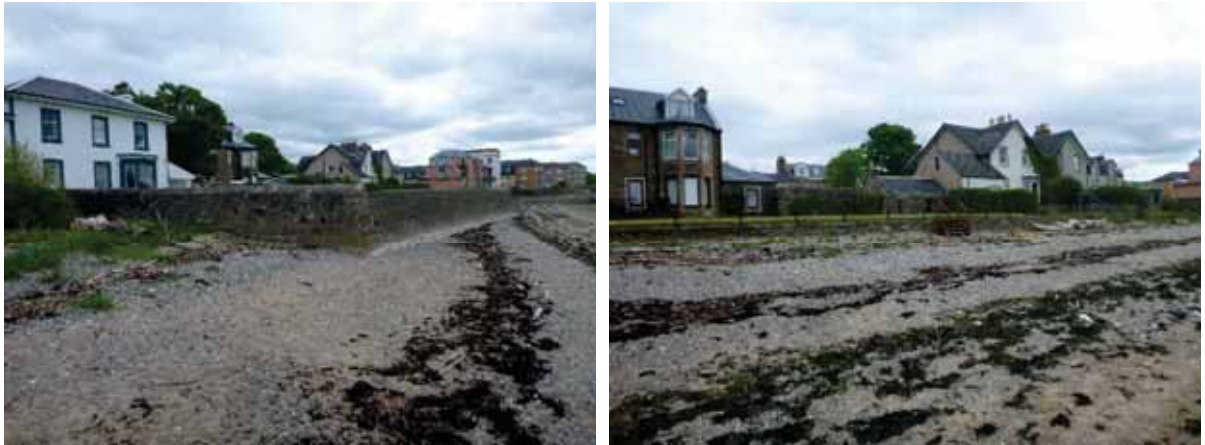
Figure 4-46: Photographs of defences within section V

Section V consists of private property boundaries that border the beach. The height of the walls vary through the section.

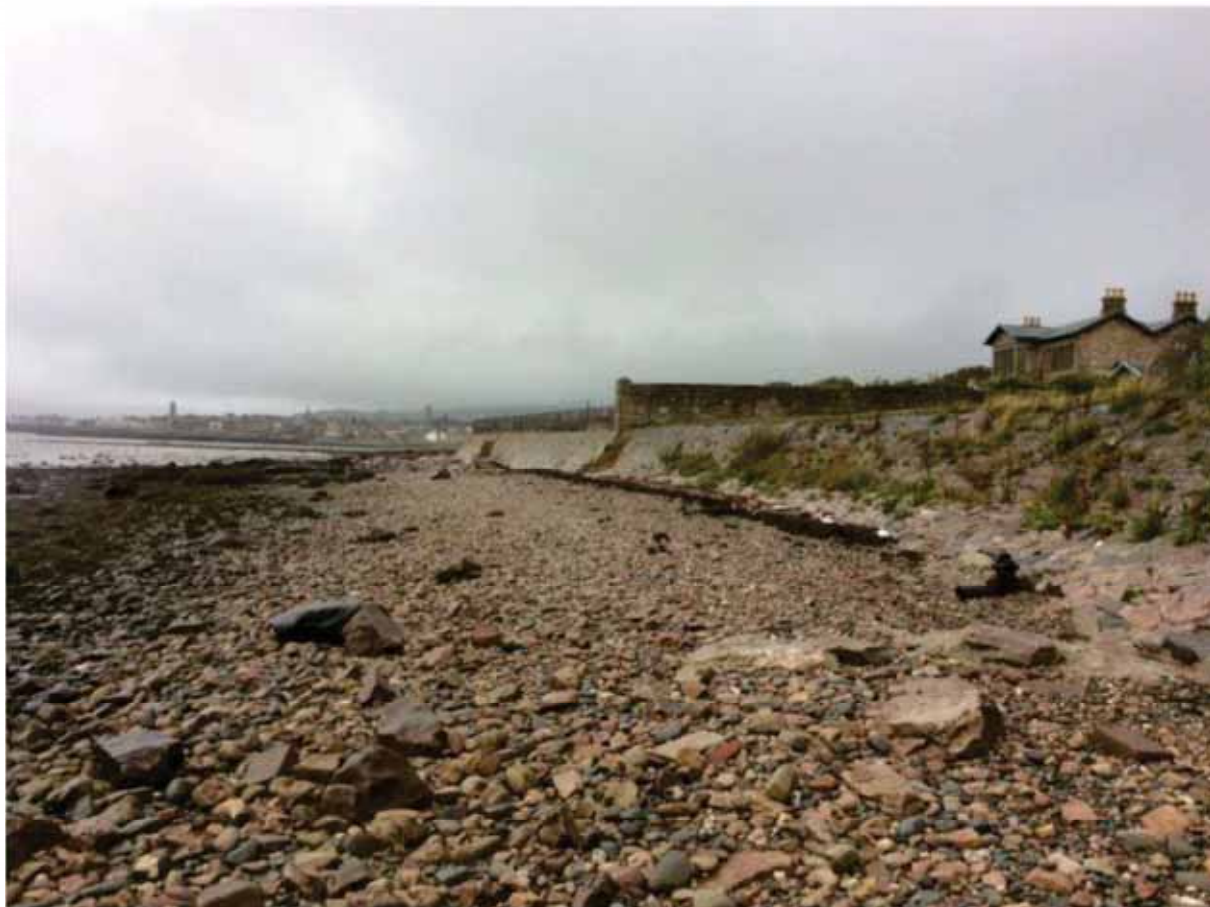
**Figure 4-50: Photograph of defence within section X**

Section X consists of private property boundaries that border the beach.

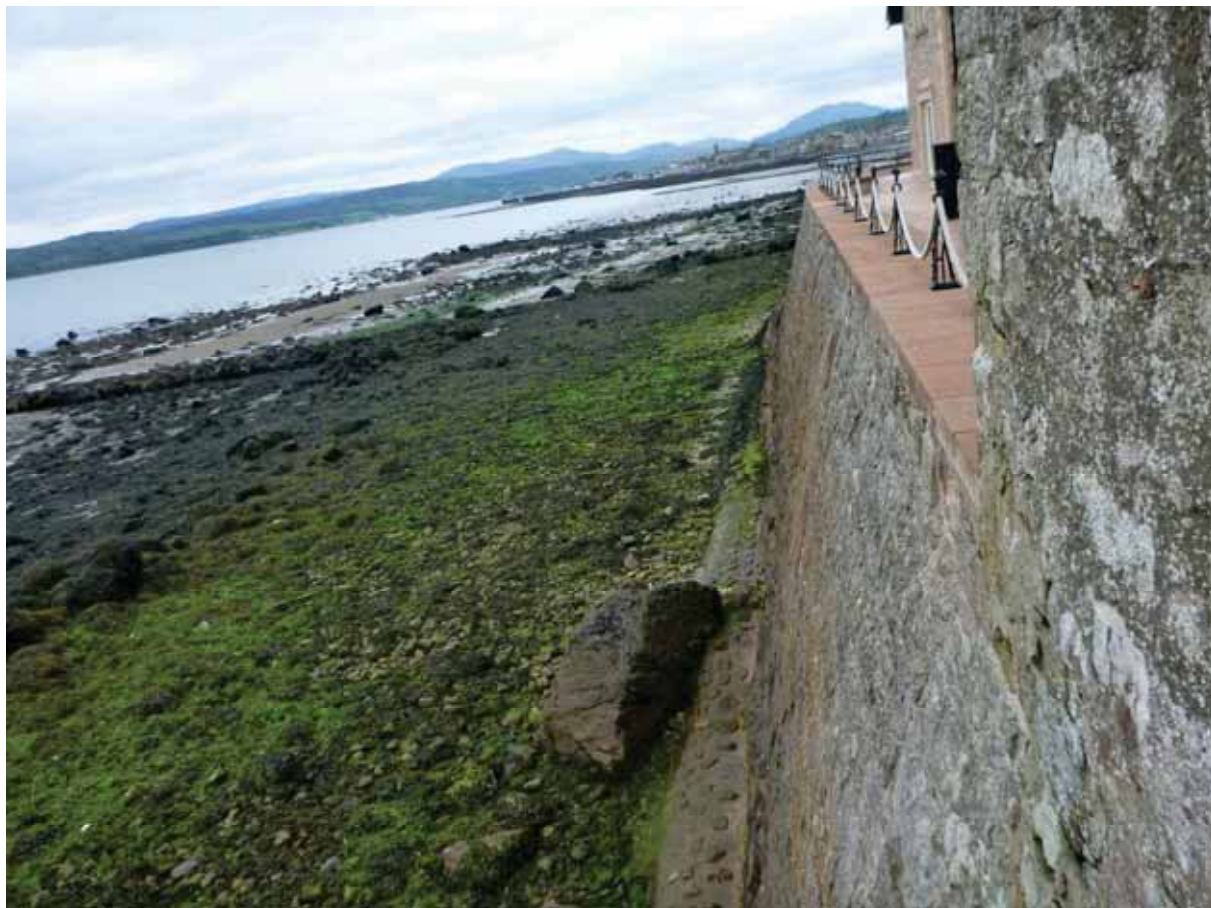
**Figure 4-52: Photograph of defence within section Y**

Section Y consists of a private property boundary that borders the beach.

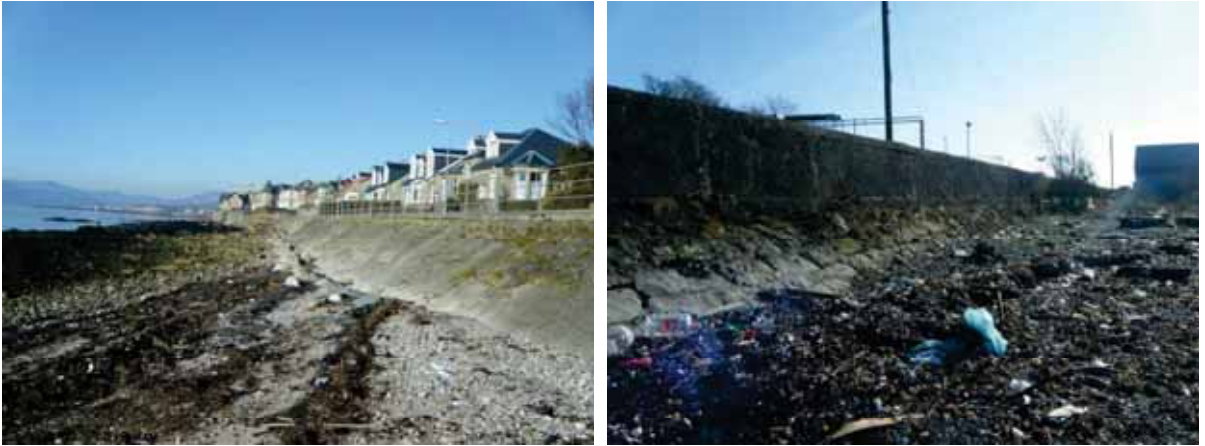
Figure 4-54: Photographs of defences within section Z

Section Z consists of a concrete revetment that protects the private road (Middleton Drive) and properties just to the west of Craighendoran Pier, as well as a concrete wall that protects Station Road.

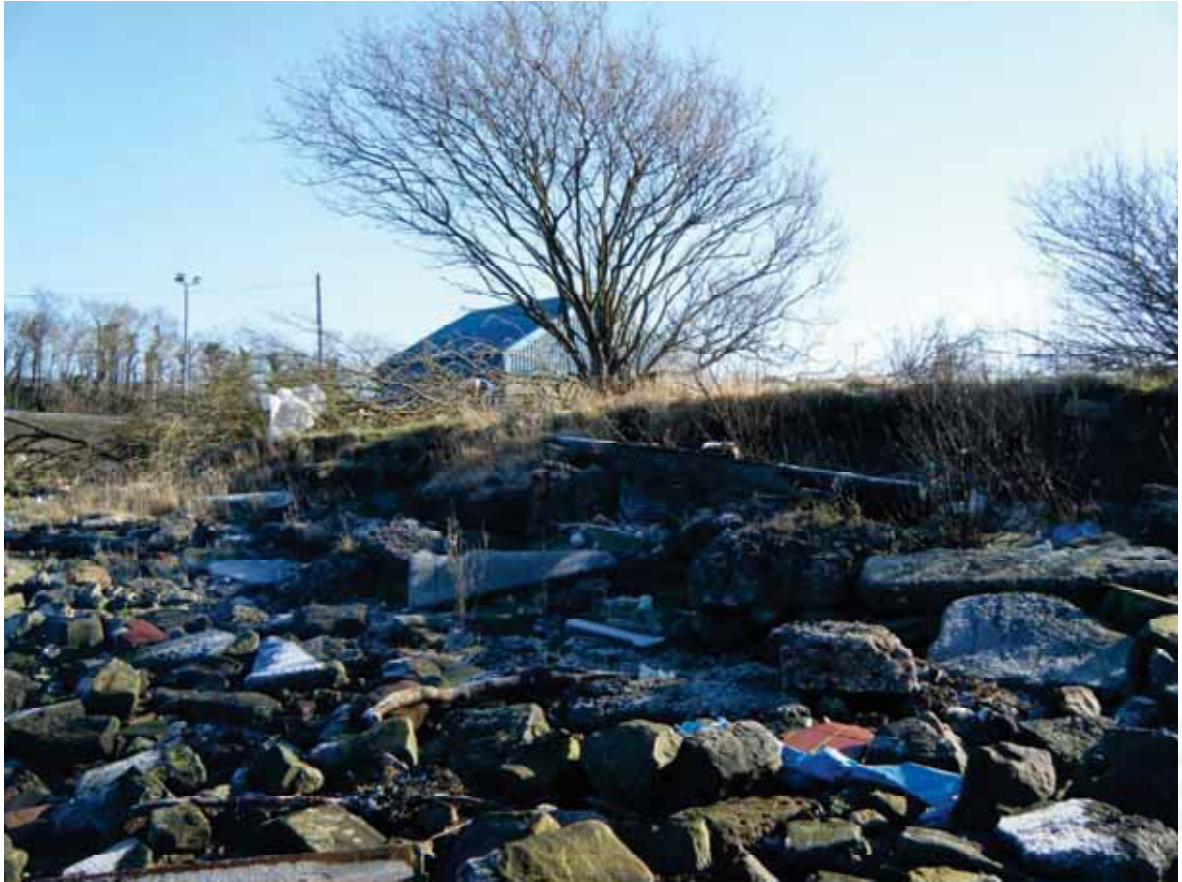
**Figure 4-56: Photograph of defence within section AA**

Section AA consists of a rocky foreshore and a vegetated grass embankment. Although the foreshore consists of substantial concrete blocks, these are not considered to be a formalised defence structure.

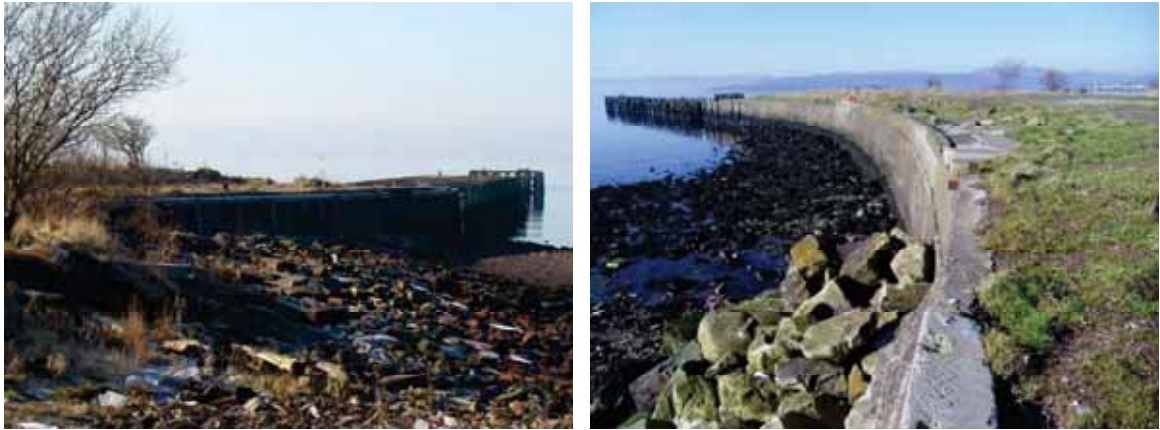
**Figure 4-58: Photographs of defences within section AB**

Section AB forms the main defences to Craigendoran Pier, and is in the form of a vertical concrete wall. Localised rock armour placements also exist.

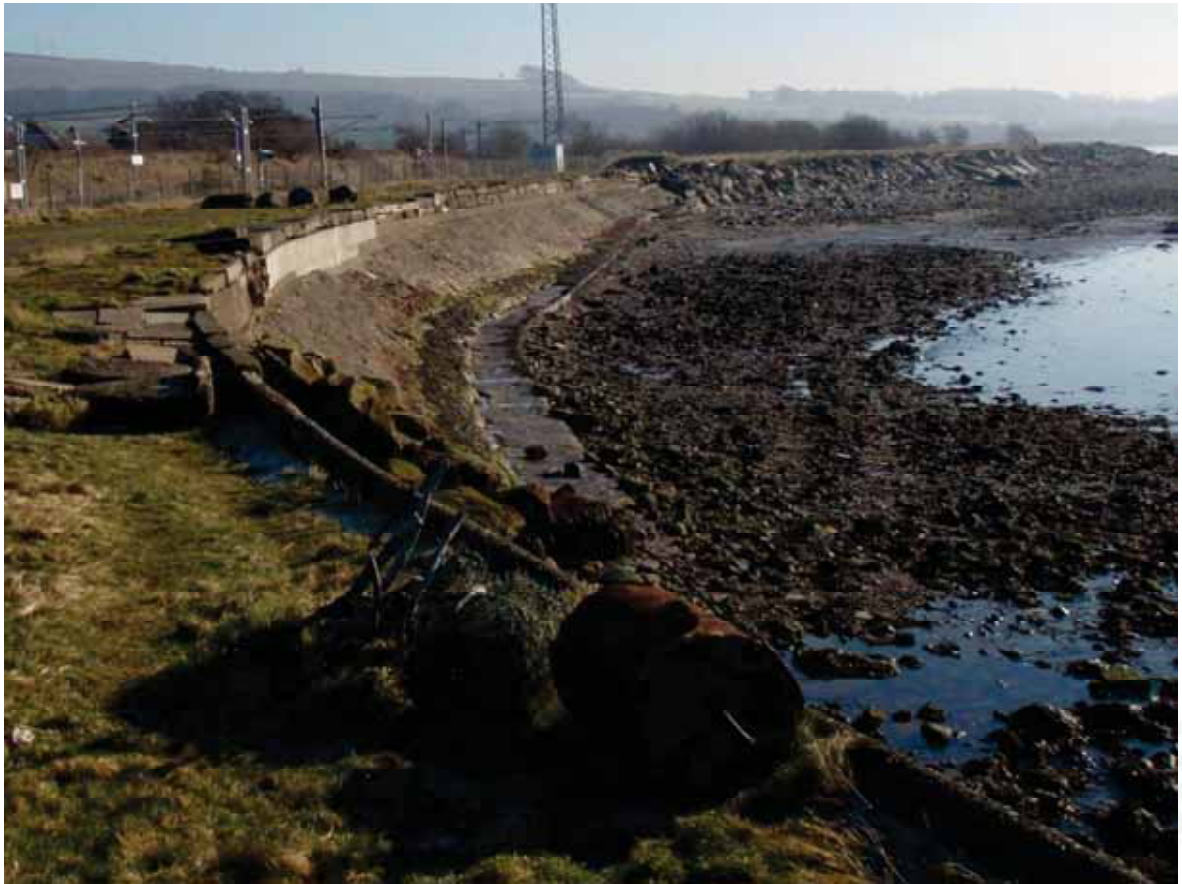
**Figure 4-60: Photograph of defence within section AC**

Section AC lies to the east of Craigendoran Pier and consists of a masonry revetment topped, in part, by a small concrete wall. The revetment appears relatively uniform along the length, but the crest elevation of the wall varies.

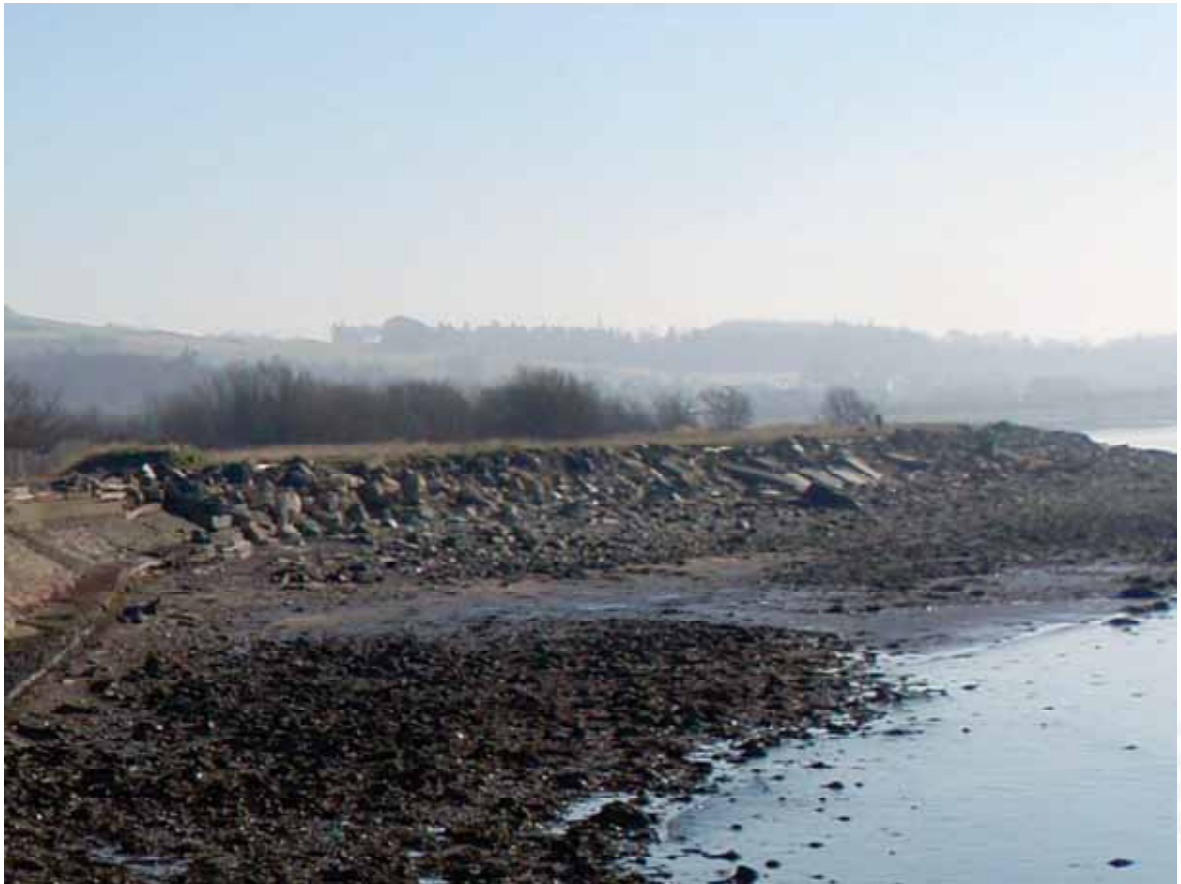
**Figure 4-62: Photograph of defence within section AD**

Section AD consists of rock armour placements that back onto a grass embankment. Localised placements of concrete and masonry are also evident suggesting that this is an ad hoc defence to prevent erosion.
