This report describes work commissioned by Grant Whyte on behalf of Argyll & Bute Council by Purchase Order number AB315359. Argyll Bute Council's representative for the contract was Grant Whyte. Steven Thomson of JBA Consulting carried out this work.

The aim of a surface water management plan is to reduce the risk of surface water flooding in the most sustainable way as required by the FRM Act. It is a plan which outlines the preferred surface water management strategy in a given location. In this context surface water flooding describes flooding from artificial drainage networks (sewers & drains), groundwater, runoff from land (pluvial), small watercourses and ditches (including culverts) that occurs as a result of heavy rainfall.

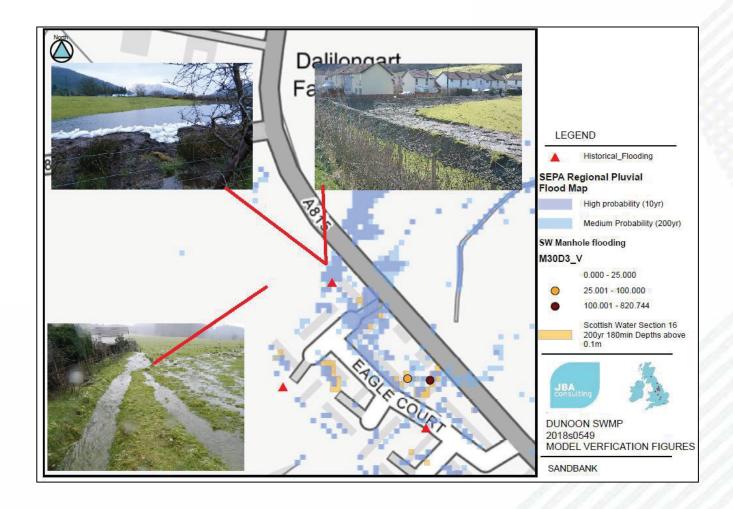
The modelled and observed data has shown that this area is considered to be at significant risk of surface water flooding. There is a strong correlation between the model and observed data, particularly in high risk areas. However, the model does not account for mitigation measures installed by the council which are known to have lowered the flood risk in particular areas. Overall, the model confidence is moderate in this SWMP area.

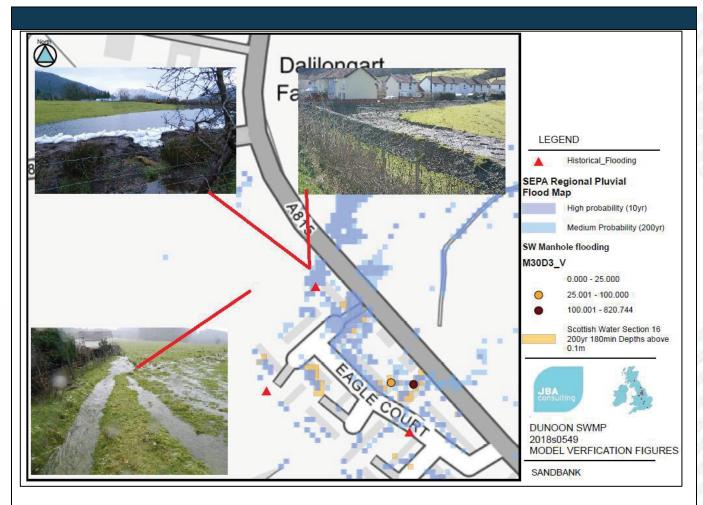
There are 2 related flood mechanisms that effect Eagle Court. Surface runoff from the grassed hillside to the south west often overtops drainage infrastructure resulting in nuisance flooding of gardens to the properties on the western extent of the development. Similarly, overland flow from the hillside effects properties at the northern extent of the development. Here, hillside runoff is combined with flows from a blocked drain. All flows are directed to the south eastern corner of the field adjacent to properties. Damages typically include interior flooding of multiple properties. An informal flood bund has been constructed to help retain the flood water. Flood water is known to have breached the bund since it was constructed.

The model does not represent the nuisance flooding of the gardens to the west due to the water not ponding and just flows over the gardens. However, the model does show ponding in the field to the north east and highlights the low-lying properties of Eagle Court that could be affected.

There is a good correlation between modelled pluvial data and historic flooding data therefore the alignment with the model is good and confidence at this location is high.

Damages in Eagle Court are significant including interior and exterior flooding of multiple properties. Ponding on the B836 is also known to have closed the road at times. The current flood risk is high as the flooding is known to be recurring and the informal defences have failed to mitigate flood risk. The flood hazard is also high due to the damages caused and a significant breach of the informal structure could cause high velocities. There is an opportunity to mitigate or partially mitigate future flood risk through a potential housing development for the site. The future flood risk is likely to increase as a result of more frequent intense rainfall events associated with climate change which will further increase the depth of flood water and potentially increase the flood extent.

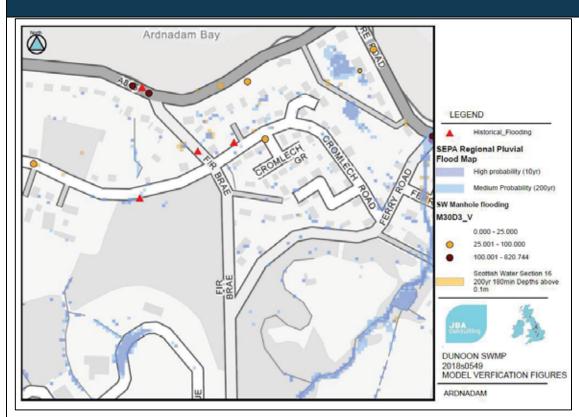
There are 2 flooding mechanisms at work at this location both coming from an unnamed watercourse to the south west of the junction of Cromlech Road and Fir Brae. At this location the watercourse enters a culvert which is prone to blockage. When the culvert is blocked flows spill down Fir Brae to the north east. Due to the steepness of the road, flows have caused delamination in the past resulting in remedial resurfacing.

Also, flows often enter the culvert at the junction with Fir Brae but then surcharge at a downstream manhole sending floodwaters through the garden of a property on Cromlech Road. It is not known if the property is damaged when flood water flows through the garden.

Flows from a minor watercourse and SuDS from Highland Avenue flow down a wooded hillside to the north of Highland Avenue. The watercourse and hillside runoff collects in drainage ditches and channels flowing adjacent to Cromlech Road. Several of the drainage ditches drain to a single culvert which conveys flows south under the road and into a private property. This culvert is prone to substantial blockage at the headwall which causes water to over top on to Cromlech Road. Once on Cromlech Road flows head east before turning north and flowing down Fir Brae. There are reports of ponding on Shore Road approximately adjacent to the junction with Fir Brae. It is possible that flood water from Fir Brae ponds here however, the model also shows substantial manhole surcharging volumes. A manhole to the east of the Fir Brae and Cromlech Road junction is also prone to surcharging sending flows into the garden of a neighbouring property and out onto Shore Road. It is assumed the surcharging is linked to the surface water issues discussed above. Damages to the property as a result of surcharging are understood to be restricted the garden only. Fir Brae has also suffered damages to the road surface course due to the high velocity of flood water.

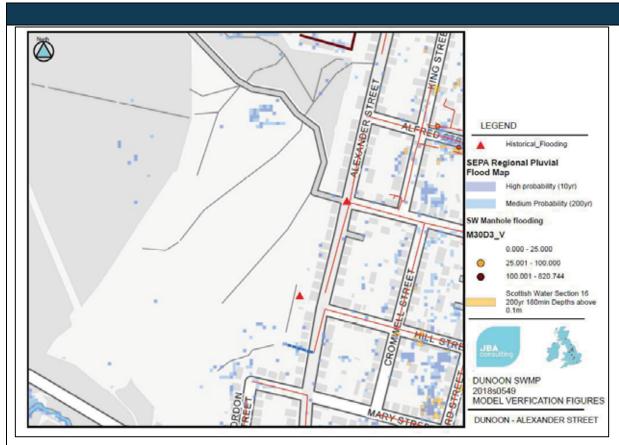
The hillside to the west of Alexander is the source of 2 flooding mechanism. Firstly, hillside runoff is known to overtop existing drainage ditches, a cause nuisance flooding to the rear gardens that border the hillside. The second mechanism is due to the network of the hillside ditches and drains which collect and discharge in to a culvert at the junction with John Street.

The watercourse is prone to blockage at the headwall causing flood water to overtop which forces flows onto Alexander Street. The road camber in this area directs flows south along Alexander Street where it enters the drainage system of a low-lying residential property causing substantial interior damage.

At this location there is very little modelled flooding however it has been highlighted by historic observed data hence the confidence in the model data at this location is low as the model alignment is poor. However, the regional scale of the mapping would not be able to represent the drainage ditch system due to small scale of the ditch network.

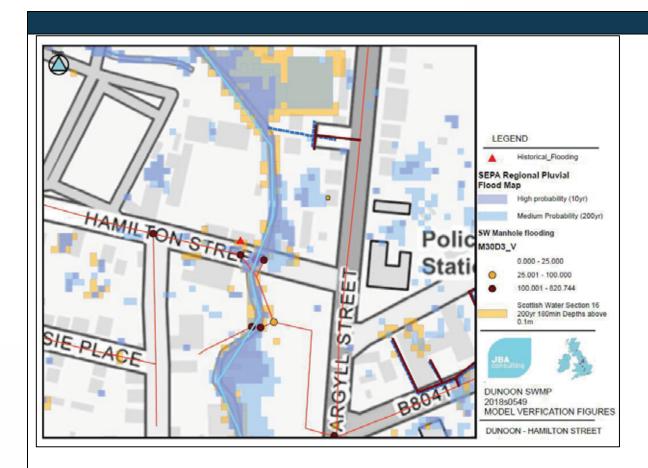
Flooding of 2 properties occurred due to the overtopping of the adjacent Milton Burn. It has been assumed that over topping was due to the partial blockage of the culvert under Hamilton Street. However, the model also shows significant manhole surcharging in this area which could be related to the watercourse overtopping. Damages were thought to include both external and internal damages.

There is a good correlation between modelled pluvial data and historic flooding data therefore the alignment with the model is good and confidence at this location is high.

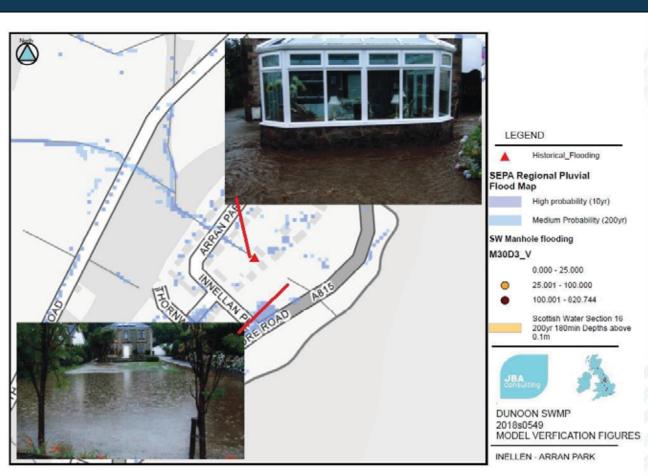
A minor watercourse which drains the steep hillside to the west is culverted below Arran Park (Road) then briefly flows openly before being culverted as it passes below a property on Shore Road and Shore Road itself. There is a significant history of blockages and out of bank flow causing damages to gardens and significant interior property damage.

There is a moderate correlation between modelled pluvial data and historic flooding data therefore the alignment with the model is fair and confidence at this location is moderate.

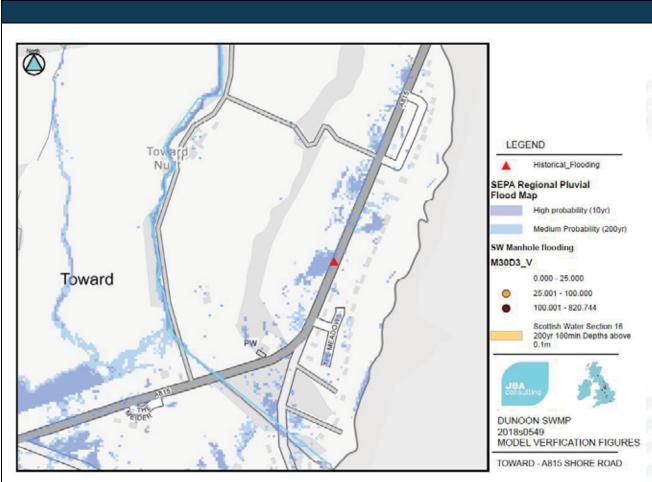
The drainage ditch/area of bog to the west of the road is prone to overtopping and flooding the road. Damages are reported to be restricted to the road which can become impassable to small vehicles.

There is a good correlation between modelled pluvial data and historic flooding data therefore the alignment with the model is good and confidence at this location is high.

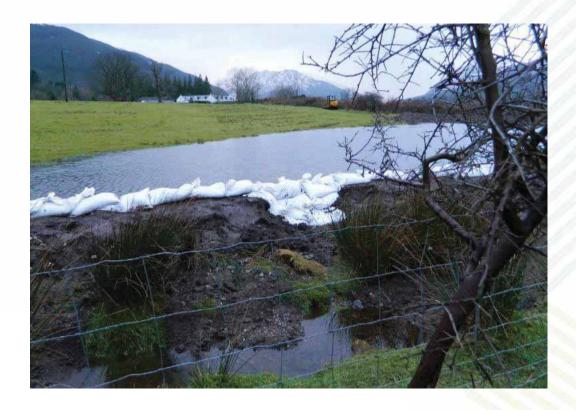
This hotspot features 3 separate minor watercourses which flow down the eastern slope of Finbracken Hill through Sandbank. Each of the watercourses are steep and entrenched with catchments consisting of commercial forestry. As such they are flashy and prone to blockages at the culverts which convey the watercourse below the road. Two of the watercourses have spilled on to the A885 in the past causing ponding on the road and threatening nearby properties. The third watercourse blocks at Cromlech Road culvert which has resulted in flooding of a garage at a property adjacent to the culvert.

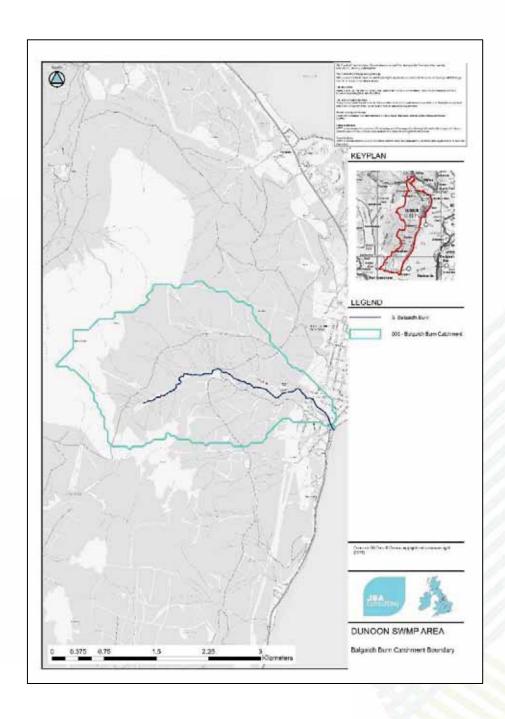
The Balgaidh Burn drains a catchment area of approximately 6.1km². Runoff from the catchment is heavily influence by Bishop's Glen Reservoir. The catchment is relatively steep with an average gradient of approximately 1:6. The watercourse originates on the upper slopes of Kilbride Hill to the south west of Dunoon. The catchment is dominated by commercial forestry. Beyond the reservoir the watercourse falls steeply in a wooded valley before flattening as it passes through a residential area.

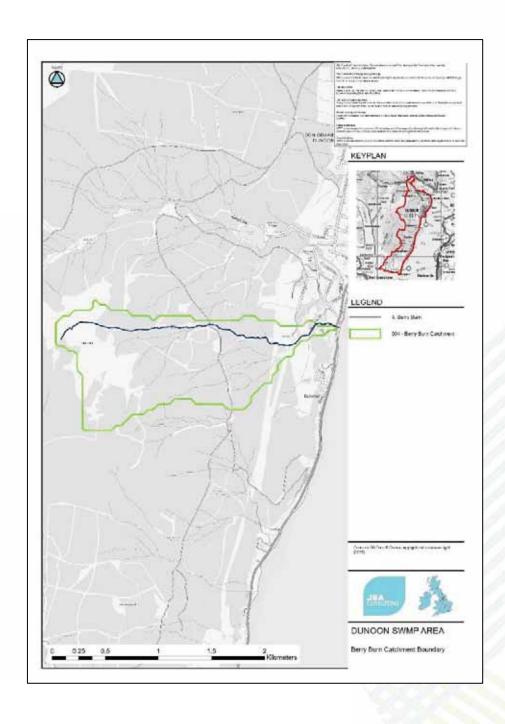
The Berry Burn catchment area is approximately 1.8km² which, like many of the catchments, is dominated by commercial forestry. The catchment is relatively steep with an average gradient of approximately 1:6. The watercourse flattens as it reaches the coast flowing open in a wooded valley before being culverted under Bullwood Road at its confluence with the Firth of Clyde.

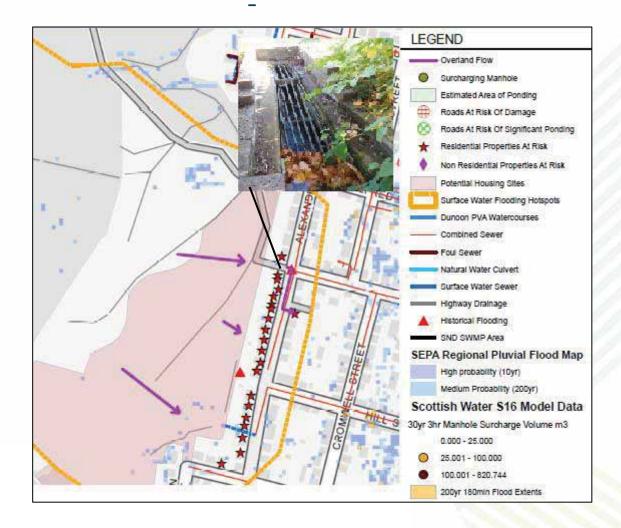
The hillside to the west of Alexander Street is the source of 2 flooding mechanisms. Firstly, hillside runoff is known to overtop existing drainage ditches a cause nuisance flooding to the rear gardens border the hillside. The second mechanism relates to the collection of the hillside ditches and drains which collect and discharge in to a culvert at the junction with John Street.

The watercourse is prone to blockages at the headwall causing flood water to overtop onto Alexander Street. Due to the road camber in this area this directs flows south along the street where it enters the ground of a low-lying residential property causing substantial interior damage. It is also understood that manholes downstream of the headwall are prone to surcharging. Damages vary from nuisance garden flooding to interior property damage.

| Rank | Hotspot name and location | | Total Annual<br>Average<br>Damage (AAD) | Non<br>Residential<br>Properties | Residential<br>Properties | Community facilities | Listed<br>buildings | Infrastructure |
|---|--|--|--|---|---|---|---|---|
| 1 | DUN_HS04:<br>Alexander<br>Street | Hillside runoff to the west of Alexander<br>Street causes nuisance flooding to the<br>rear gardens as well as out of bank flows<br>at a culvert send flows along the road<br>and into a low-lying residential property.<br>Low confidence in model data. | <i>E0</i> ( <i>£29,127 SPAADE data</i> ) | - | 21 | | | - |

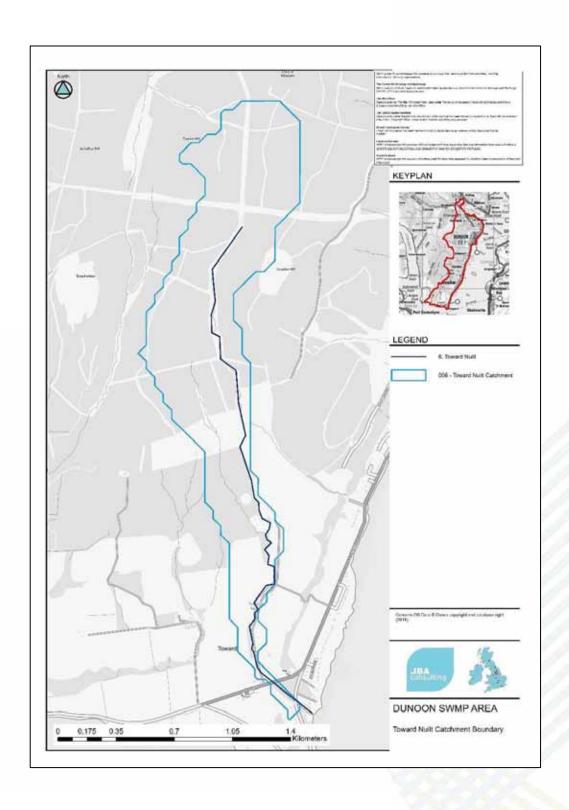
The Toward Nuilt drains approximately 1.6km² of the Innellan area. It flows across the top of Innellan Hill and falls down the rocky hillside south towards the Toward area. Toward Nuilt descends with an average gradient of approximately 1:10 through a catchment of commercial forestry.

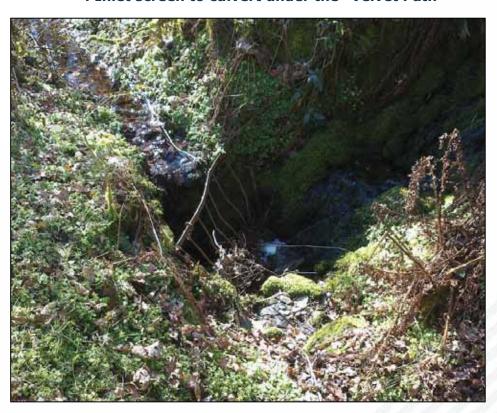
Interior and exterior damage was caused to a property on Fern Lane in 2009 when a culvert under "the Velvet Path", which runs perpendicular and upslope of the property, overtopped sending flows down the hillside and into the property. The watercourse flows steeply through a commercially forested area before flowing under the path which has a substandard and damaged screen prone to creating blockages.

| | | | | | | Pelet/Intest/M/s/ | | |
|---|---|--|---|---|---|---|---|--|
| 3 | TOW_HS04:<br>Ferns Lane | Blocked culvert on access track causes flood water to spill down the hillside toward a residential property causing interior and exterior damage. Low confidence in model data. | £0<br>(£1,387<br>SPAADE data) | - | 1 | - | 3 | - |

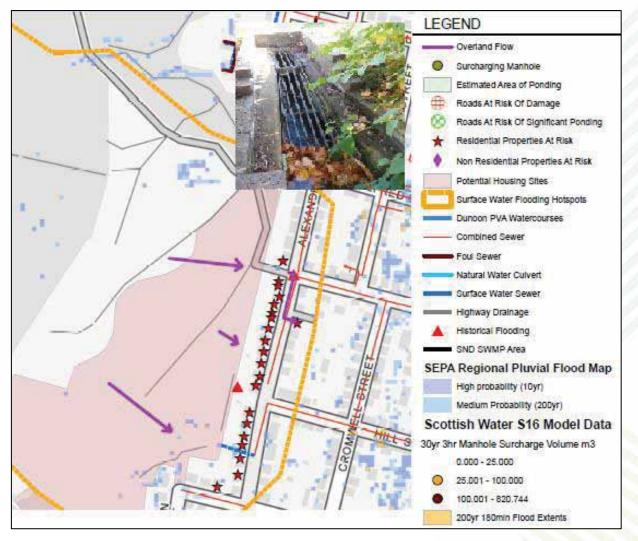
The current flood risk is high as the flooding is known to be recurring. The flood hazard is moderate as flood velocity is likely to vary however, flood depth is likely to be low. There is the potential to mitigate future flood risk by managing surface water on the proposed housing development on the hillside to the west of Alexander Street. The future flood risk is likely to increase as a result of more frequent intense rainfall events associated with climate change which may further increase the volume of flood water entering the culvert.

Using SEPAs Scottish Pluvial Annual Average Damages Estimates (SPAADE) dataset the estimated damages for this hotspot are £29,127.

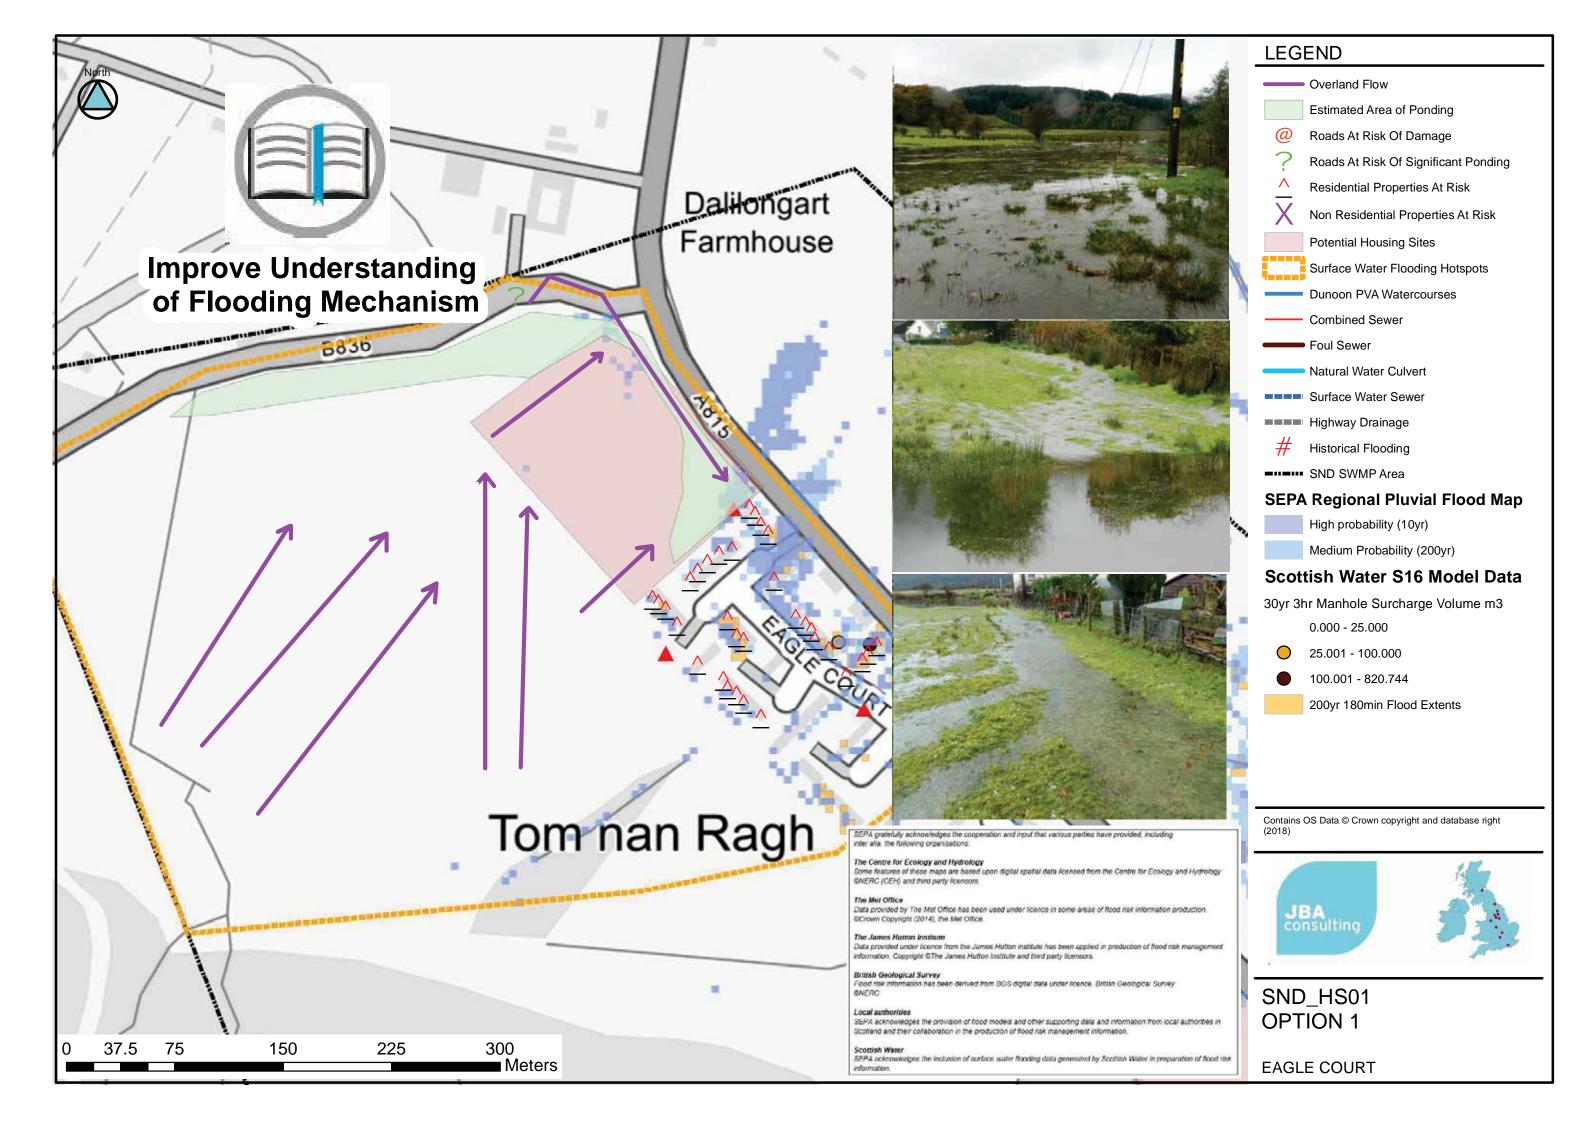
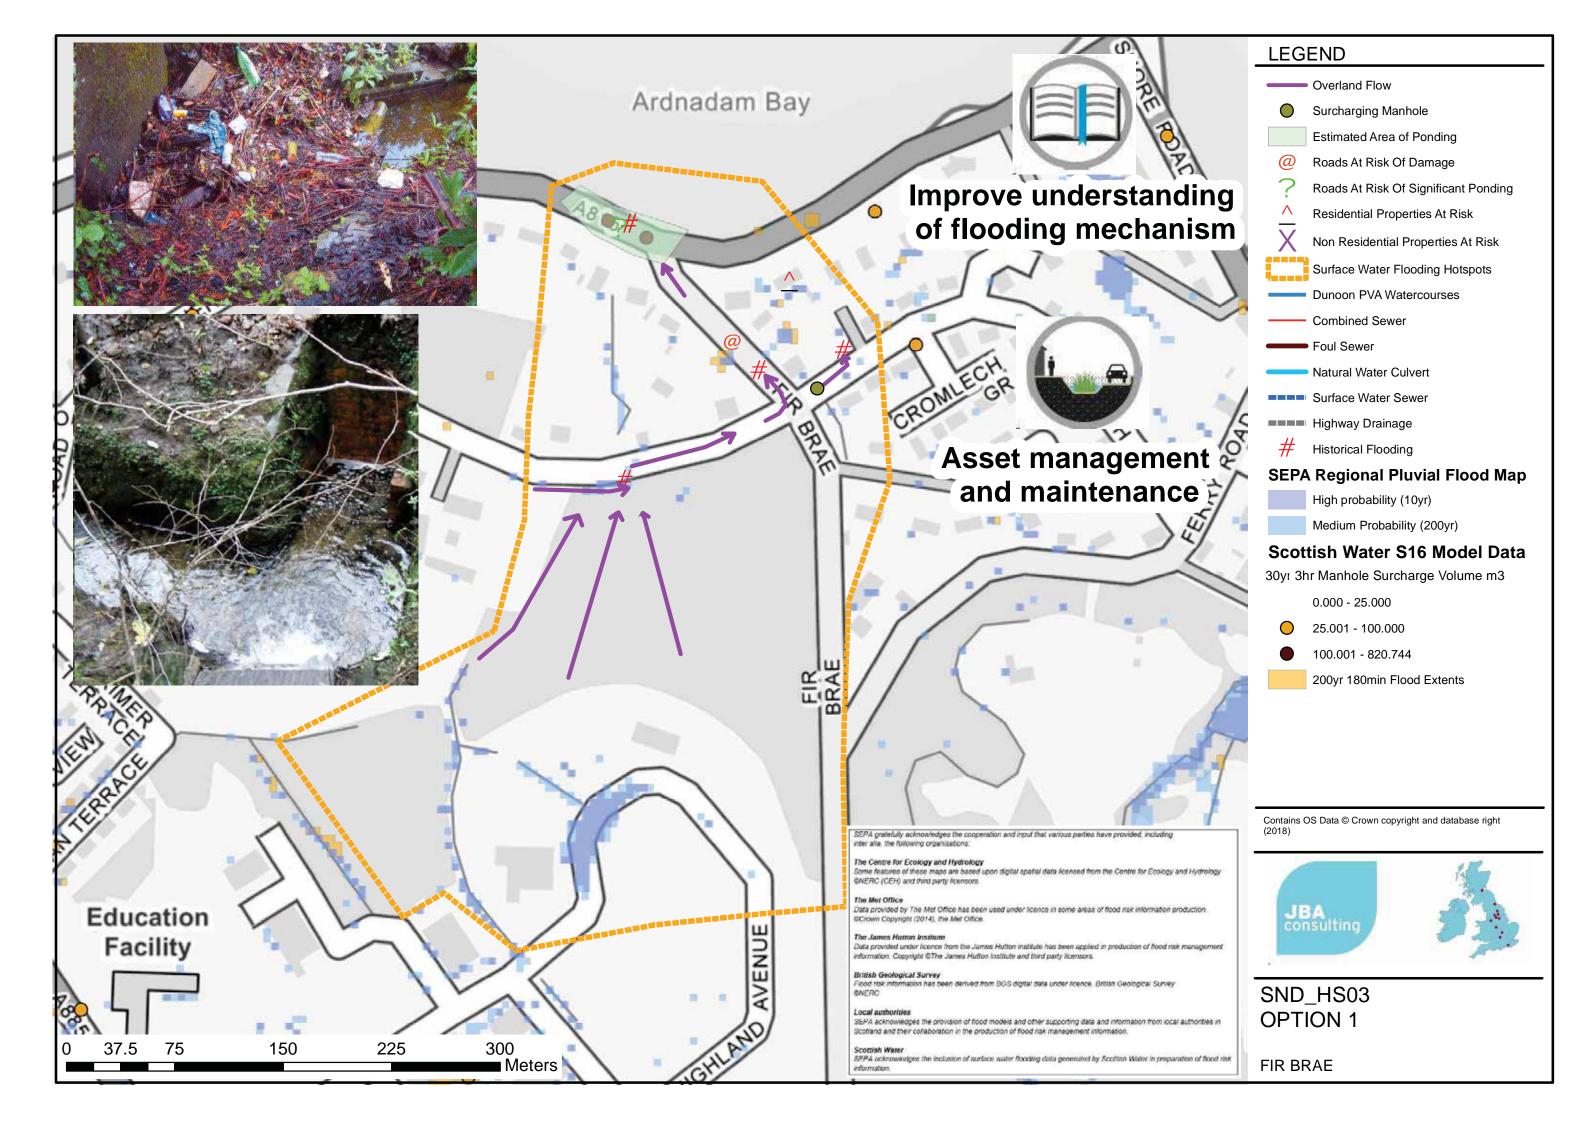
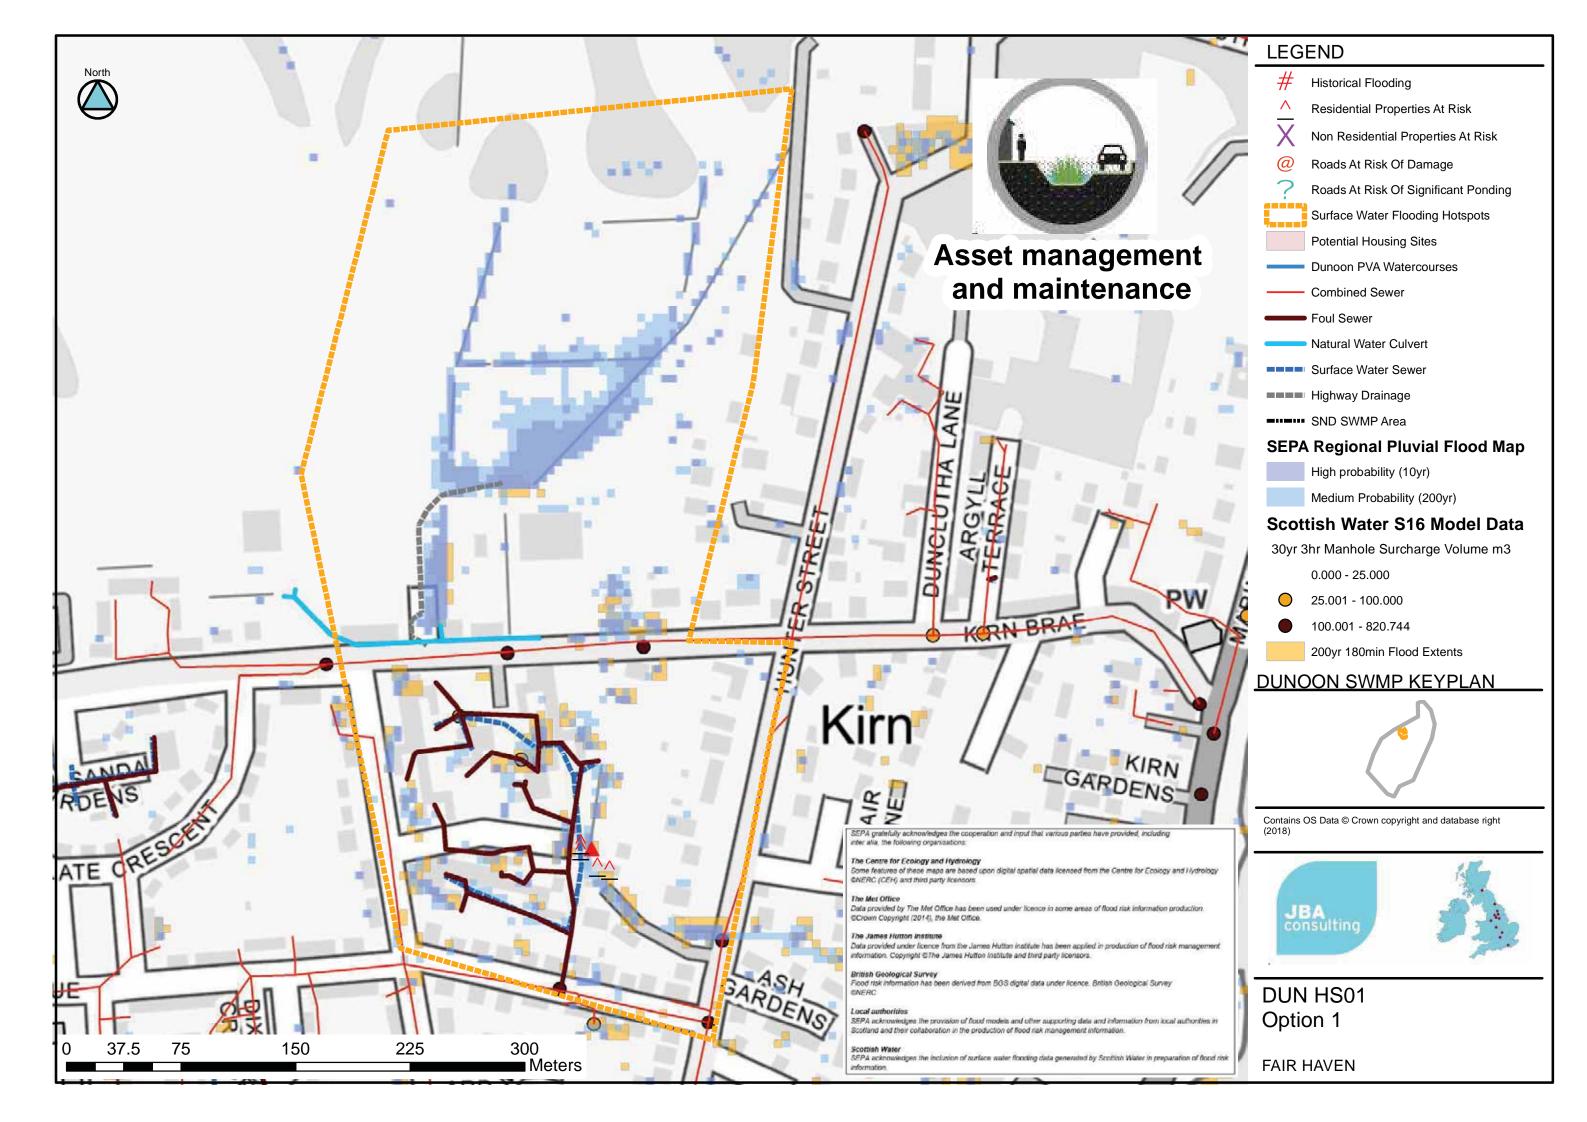
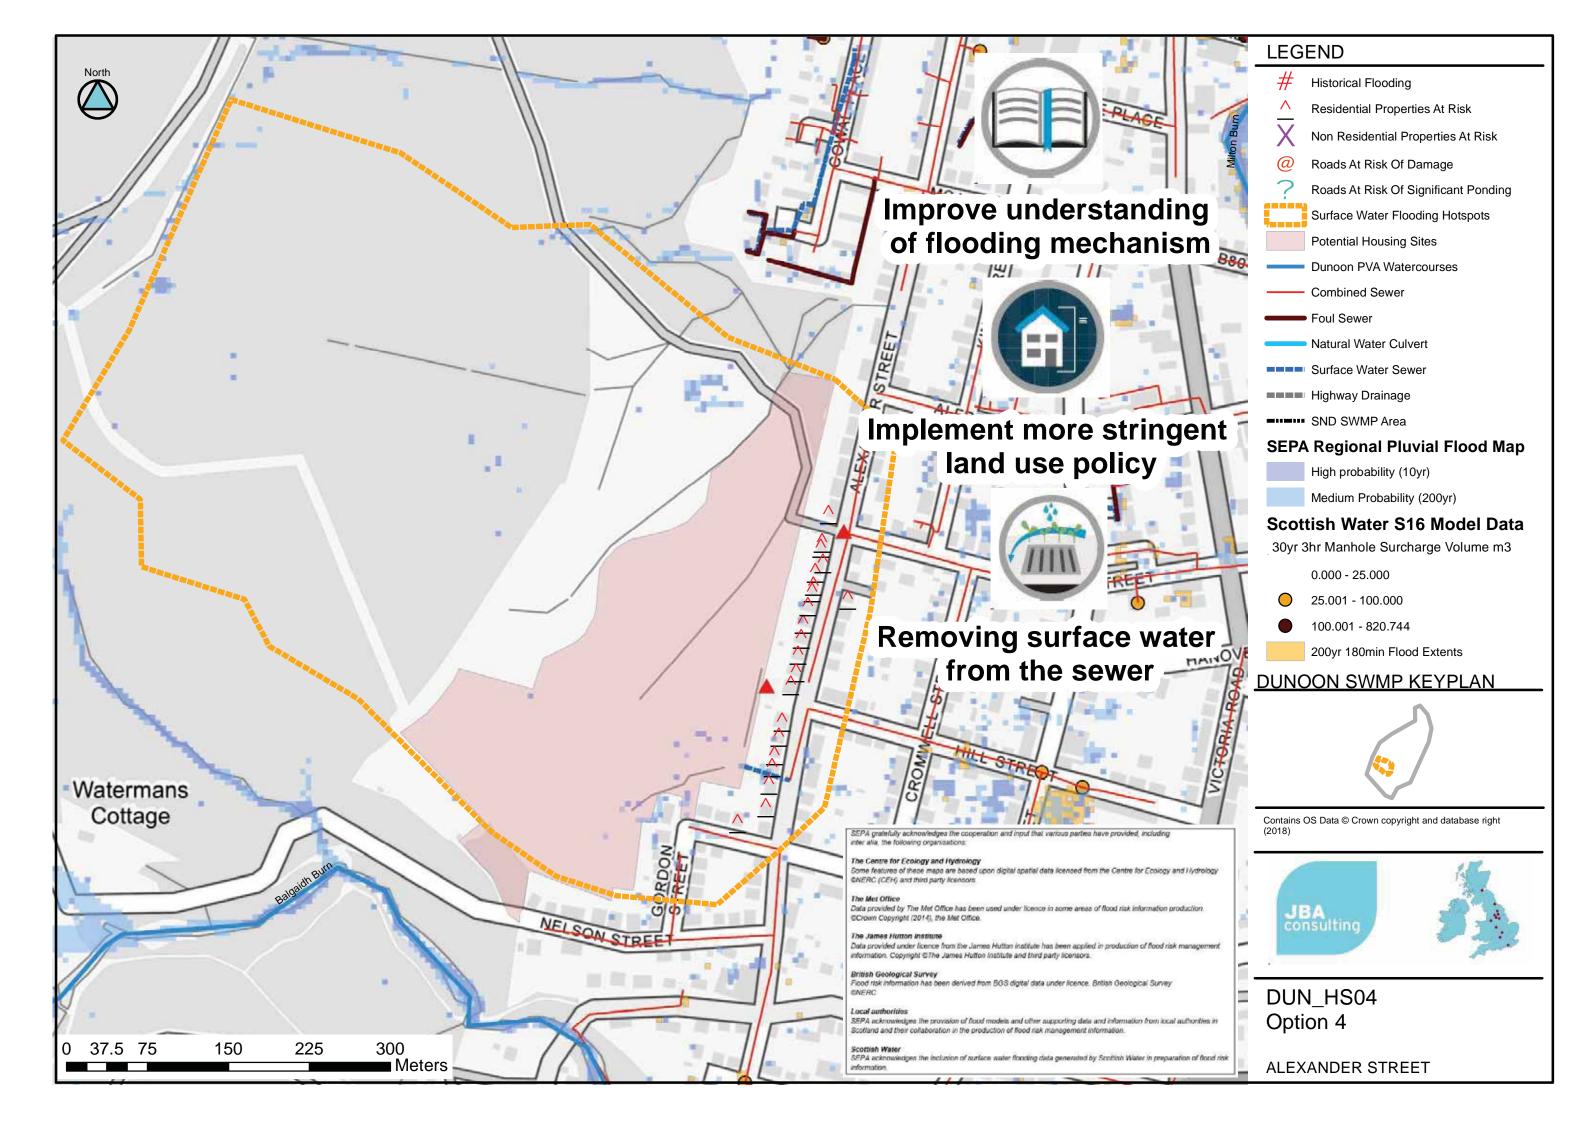
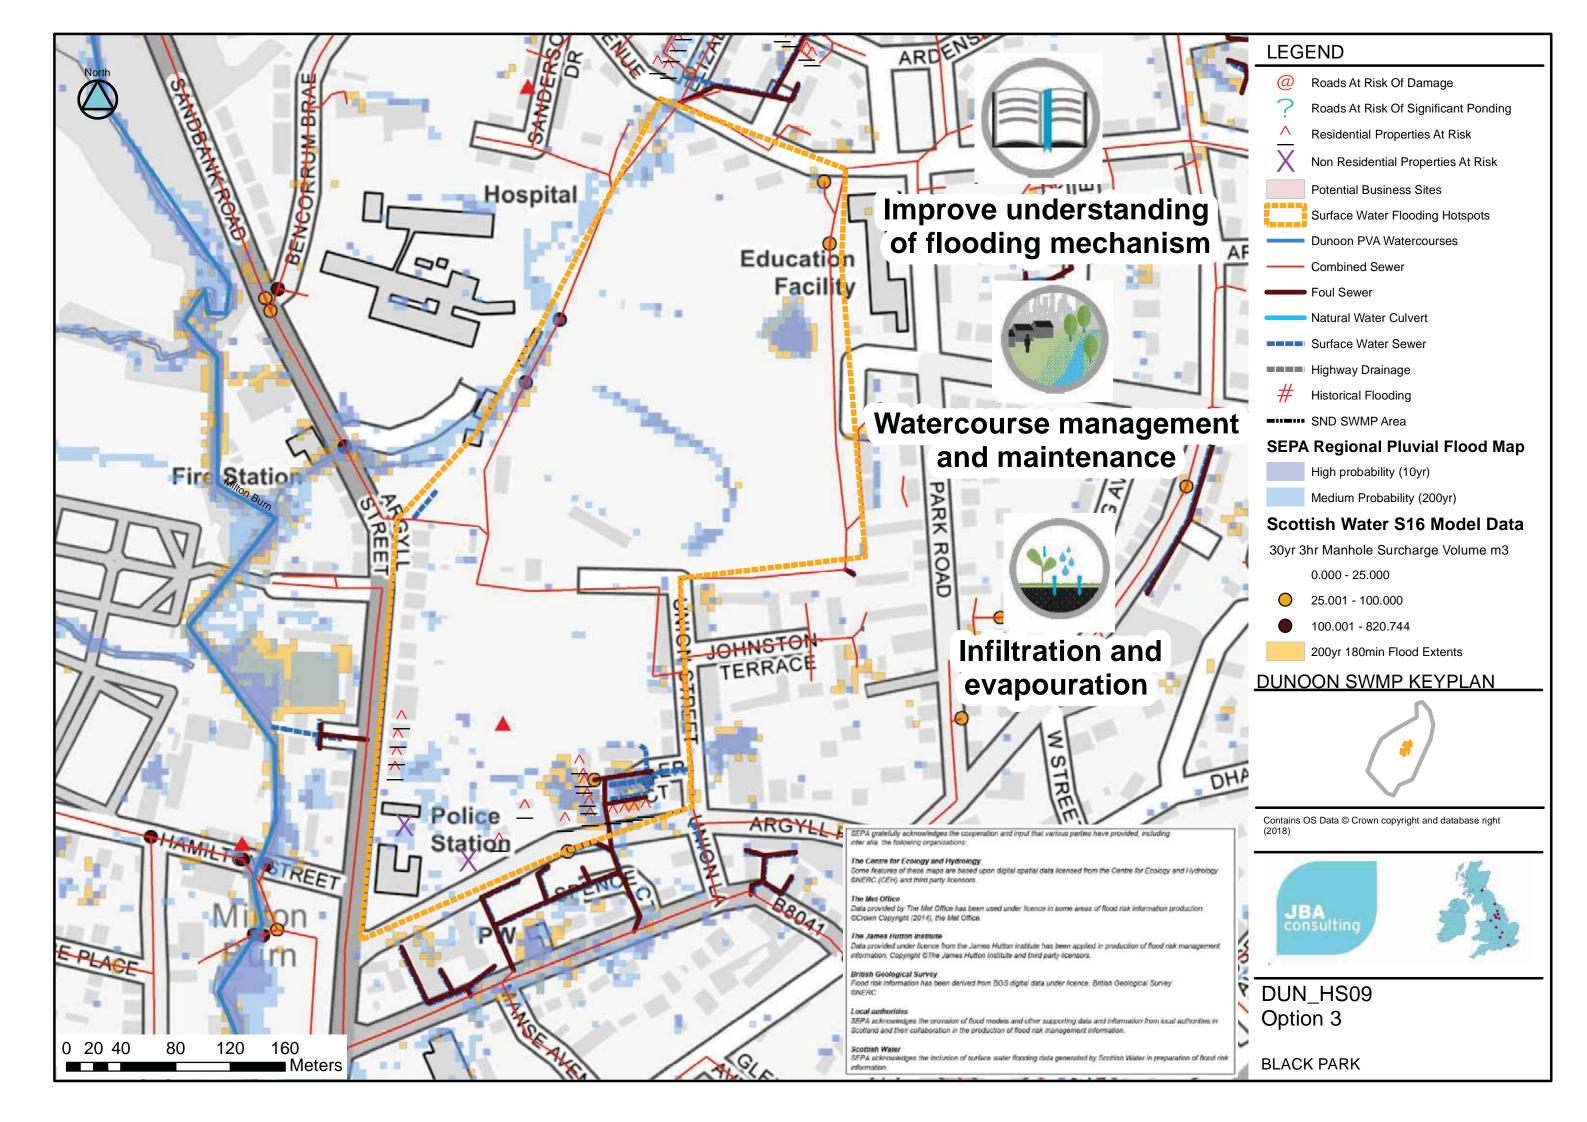
Following open discussions, the following consensuses was agreed for the 5 remaining priority hotspots. Graphical representations of the preferred options can be found in Appendix A.
