Conservation Area Appraisal & Management Plan

EASDALE

November 2019

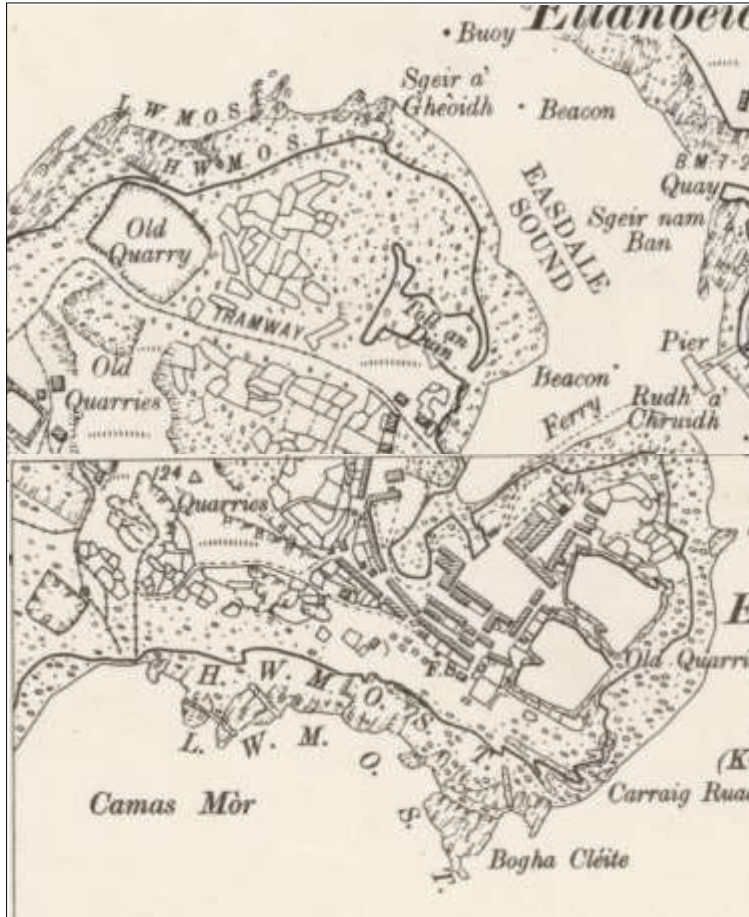
2st Series OS Map (1898)

Production at Easdale was made challenging by the fact that the slate beds lay near sea-level and were susceptible to flooding. By publication of the OS map in 1877 the two quarries to the south-east were already marked as “old quarry” and flooded. Another quarry to the north was also denoted “old quarry” but had not yet flooded. A storm in 1881 resulted in a tidal wave which swamped many more quarries on Easdale island. As the quarries fell further below sea-level, walls were built to keep the sea out. One of these, 4 metres high, stands on the seaward side of one of the largest quarries on Easdale Island.

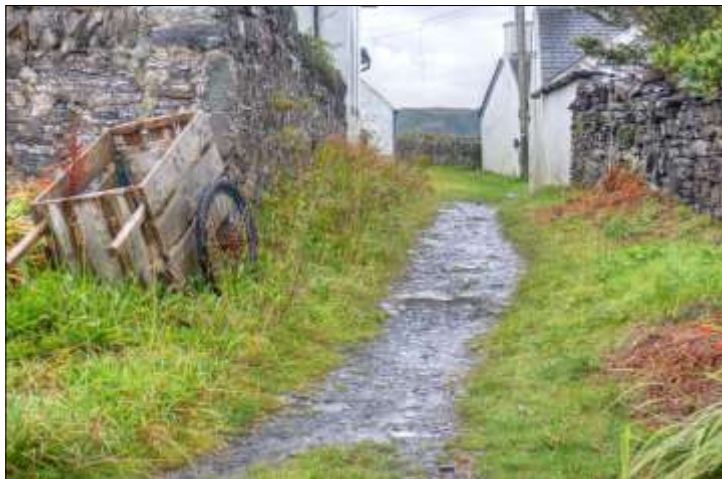
The narrow pedestrian paths are covered with pieces of slate, and provide the main routes around the island. Access to many of the houses however is across greens, of which there is a large square one on the left after departing the ferry, and further smaller ones are dotted around between the houses. Where new houses have been built to the north-east of the island a respect for the traditional landscape pattern has been maintained, with further greens incorporated into the landscape design here.

Slate path

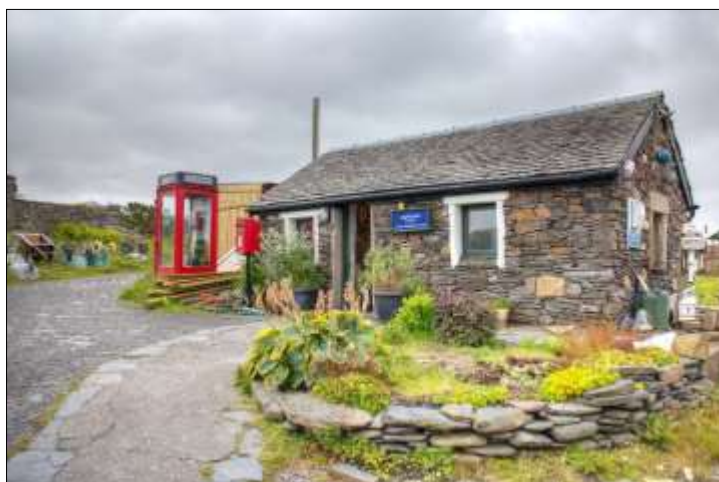
Ferry waiting room

Arrival at the conservation area is into the B-Listed harbour, where the wall has fallen into disrepair and is being propped up by timber supports. The harbour area provides the main public space, with a small ferry waiting room constructed of exposed stone, and an old K9 telephone box converted into a defibrillator unit. The outdoor space features tyre planters and wooden seating.

The B Listed harbour has fallen into disrepair and is being propped up by timber supports. The residents expressed a desire to find a means of repairing this.

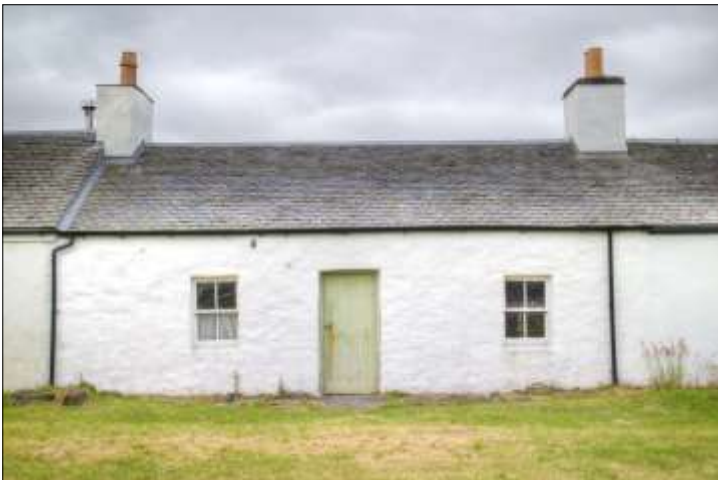
The traditional form of the cottage is single-storey with pitched slate roofs featuring chimneys, and gable ends. Porches did not feature as part of the original house form. Traditional window openings were small with timber sash and case windows, and doorways were low and wide. Although most are terraced, some detached cottages can also be seen. The cottages are generally finished in white render.

Traditional cottage

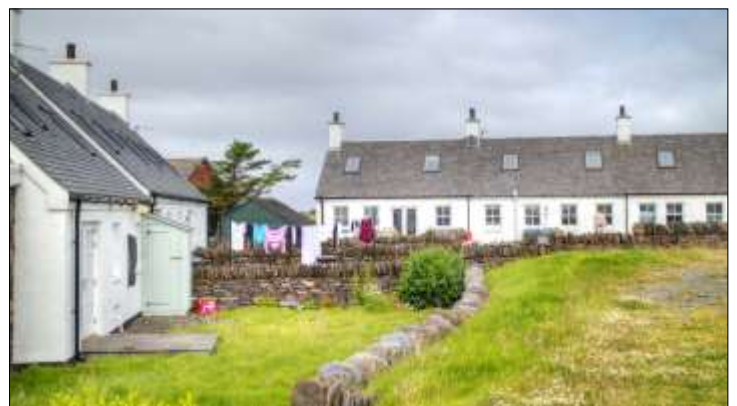
New housing has been built to the north-east of the island. These cottages follow the form of the traditional cottages and feature slate roofs (part of which are of reclaimed slates), and suitably sized chimneys. The siting of the houses directly onto greens respects the island's traditional layout, as do rear boundary walls of dry-stone slate. The windows are timber sash and case and although these feature cills (which wouldn't have been found on their traditional counterparts), these form a function in terms of protecting the building fabric and are a key component in modern building design. These are therefore a positive and welcome addition to the island's architectural character.

New housing

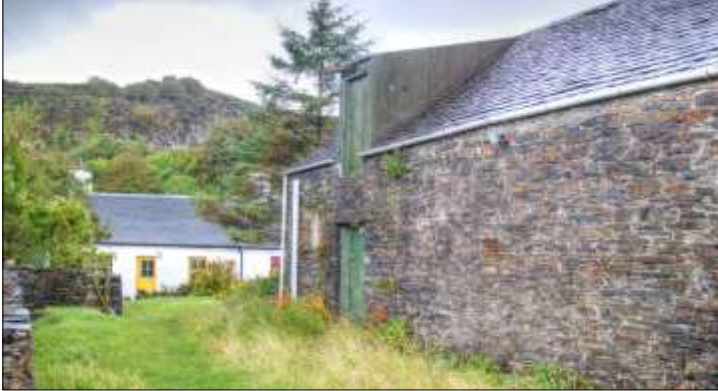
The Coalery was built in the late-19th century of exposed stone with a bell tower to the east gable. The Coalery was originally built as stables then later converted to an engine shed for the tramway. The building sits taller than the traditional island architecture due to its former function. The tall building acts as a dominant feature, significant to the history of industry on the island.

The Coalery

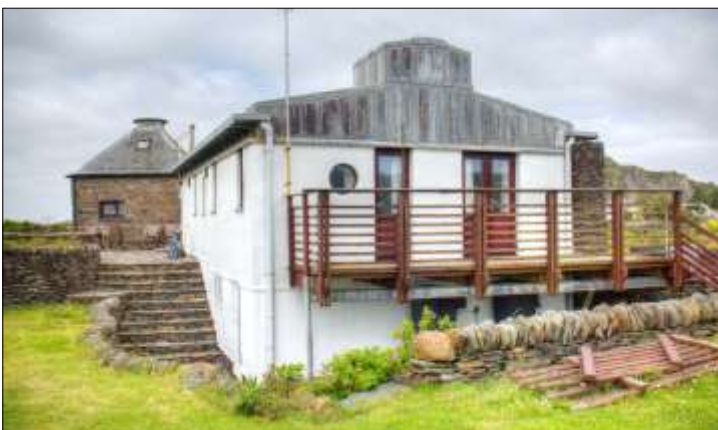
Modern house

Whilst the small single storey cottage forms the main character of the area, larger, one-off styles of architecture can also be found dotted around. A large distinct house (built 1987-92) sits to the south-east of the island bounded by low slate walls, overlooking Camas Mor. When approaching from the west the exposed stone walls tie in with the boundary walls and the relationship between the design and its context can be seen.

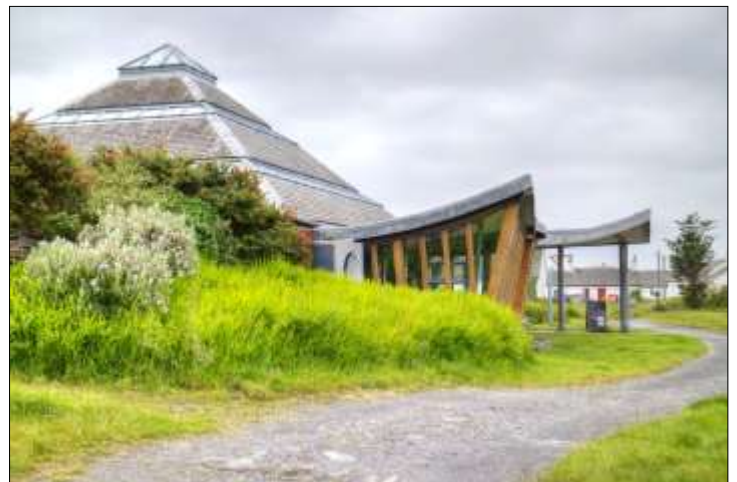
Easdale Island Hall (former drill hall) sits in a prominent position in the conservation area, being instantly visible on arrival at the island as well as from the other side of the harbour. The new structure incorporates that of the former drill hall, which was a square slate-rubble structure dating from 1871 with a high pyramid roof, as well as an old cottage. The new centre was designed in 2002 and is of a style completely different to anything else on the island, with timber protrusions contrasting sharply with the delicate nature of the island's traditional architecture. The original pyramid roof structure has been retained, but rooflights introduced. The building is C-Listed.

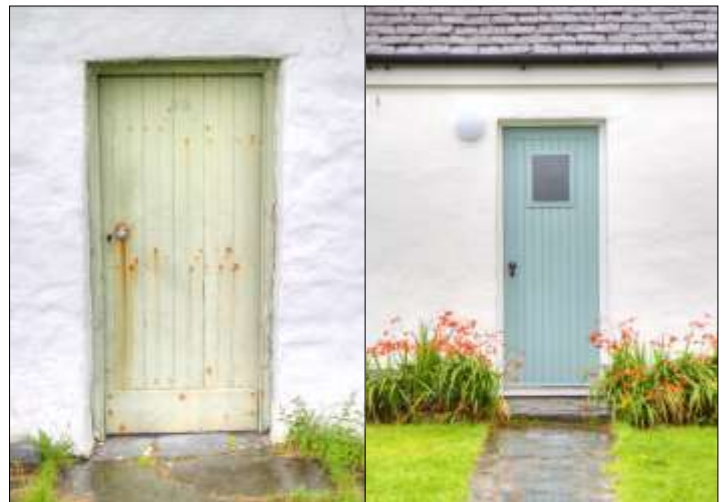
Traditional doors are low and wide. These would have been timber with simple door knobs. Modern replacements are of various styles and materials including inappropriate use of uPVC.

Traditional and new doors showing different proportions

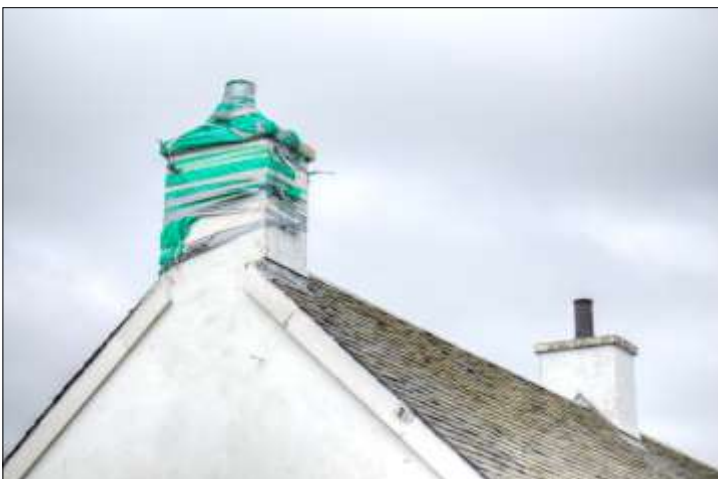
Chimney requiring maintenance

A number of cottages are in need of maintenance and repair, to varying degrees. Early repair of such buildings would not only be of aesthetic benefit to the area, but would preserve the life of these historic buildings and their traditional features. For example slipped slates can result in water ingress which will cause wetting and potential rot of the roof timbers.

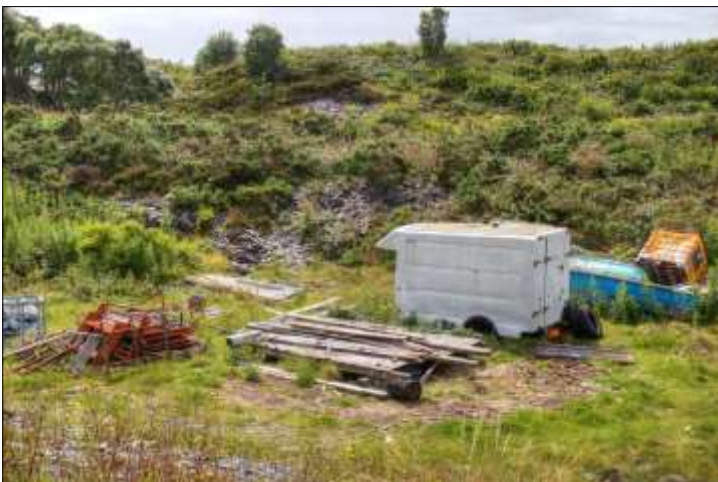
Rubbish dumped on landscape

There is currently open land to the north-west of the harbour (which is not part of the Scheduled Monument). The ground is currently mostly outwith the settlement zone so could not be used for development at this time. However, the open land is not being treasured or maintained, with parts being used as a dumping ground. There is therefore an opportunity to tidy this up and make better use of the land through environmental improvements.

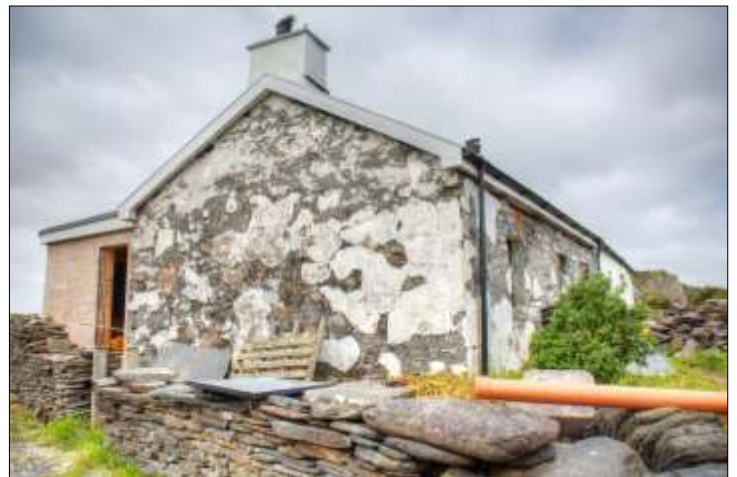
The former slate worker's cottage which is designated "At Risk" should be repaired and developed to a wind and watertight standard in order to preserve the building fabric. A planning application and a Listed Building application were submitted in 2004. The proposal included the demolition of a rear shed, to be replaced with a new lean-to extension, as well as replacement of the existing roof and new render to be applied to the existing stone walls. However at the last site visit the remedial works had still not been completed. There is an opportunity to complete these vital works and restore the cottage to a habitable condition. Consideration should be given to a lime render (see section 6.3.4)

Cottage "At Risk"

There is one registered Building at Risk on Easdale, which is an early 19th century former slate worker's cottage (number 34) located to the west of An Lionadh. The building was in ruinous condition in 2012 when last appraised by Historic Environment Scotland (HES). Photos by HES and the Scottish Civic Trust show the building had no roof. A planning application and a Listed Building application were submitted in 2004 but at the last site visit works were not yet complete. The slate roof is now reinstated.

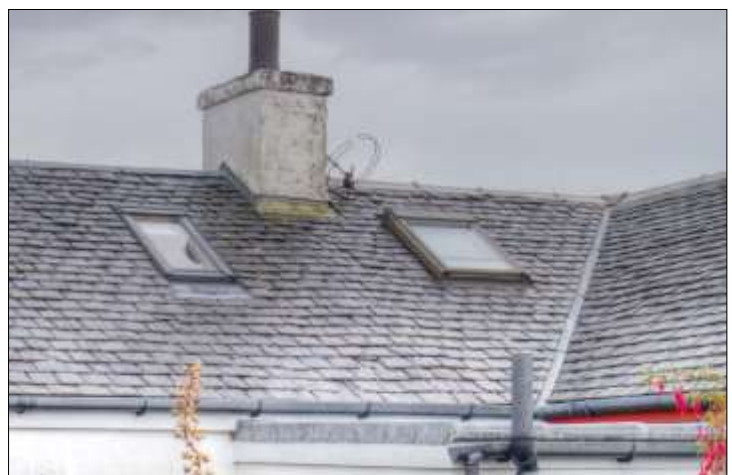
Rooflights were not a traditional feature of the majority of buildings, therefore whilst insertion of such may be completely acceptable, there is no reason for these to feature a "conservation style" bar down the centre. They should, however, be appropriately small, narrow and flat.

Contrasting rooflights, demonstrating how the low profile and slenderness of that on the left is more sensitive to the character of the area

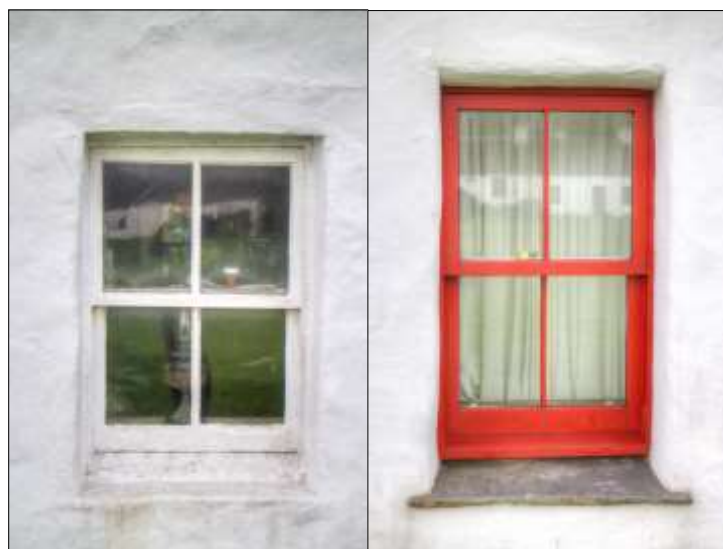
The prevailing original window type within the conservation area is timber sash and case.

Traditional style sash and case windows—no horns, no trickle vents, suitably slim astragal

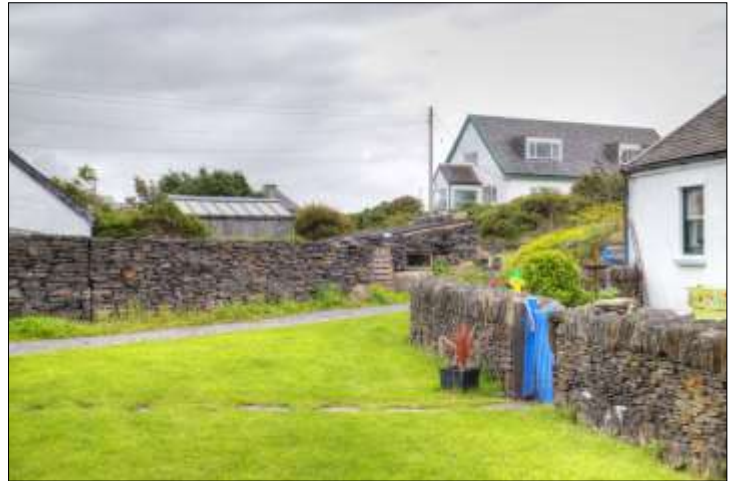
bounding rear gardens), these are traditionally of dry-stone slate walling.

Dry-stone slate boundary walls
